August 28, 2014

SUBJECT: Damage to Hoard Family Headstone – Riverview Cemetery

SUBJECT: Damage to Hoard Family Head Stone – Riverview Cemetery

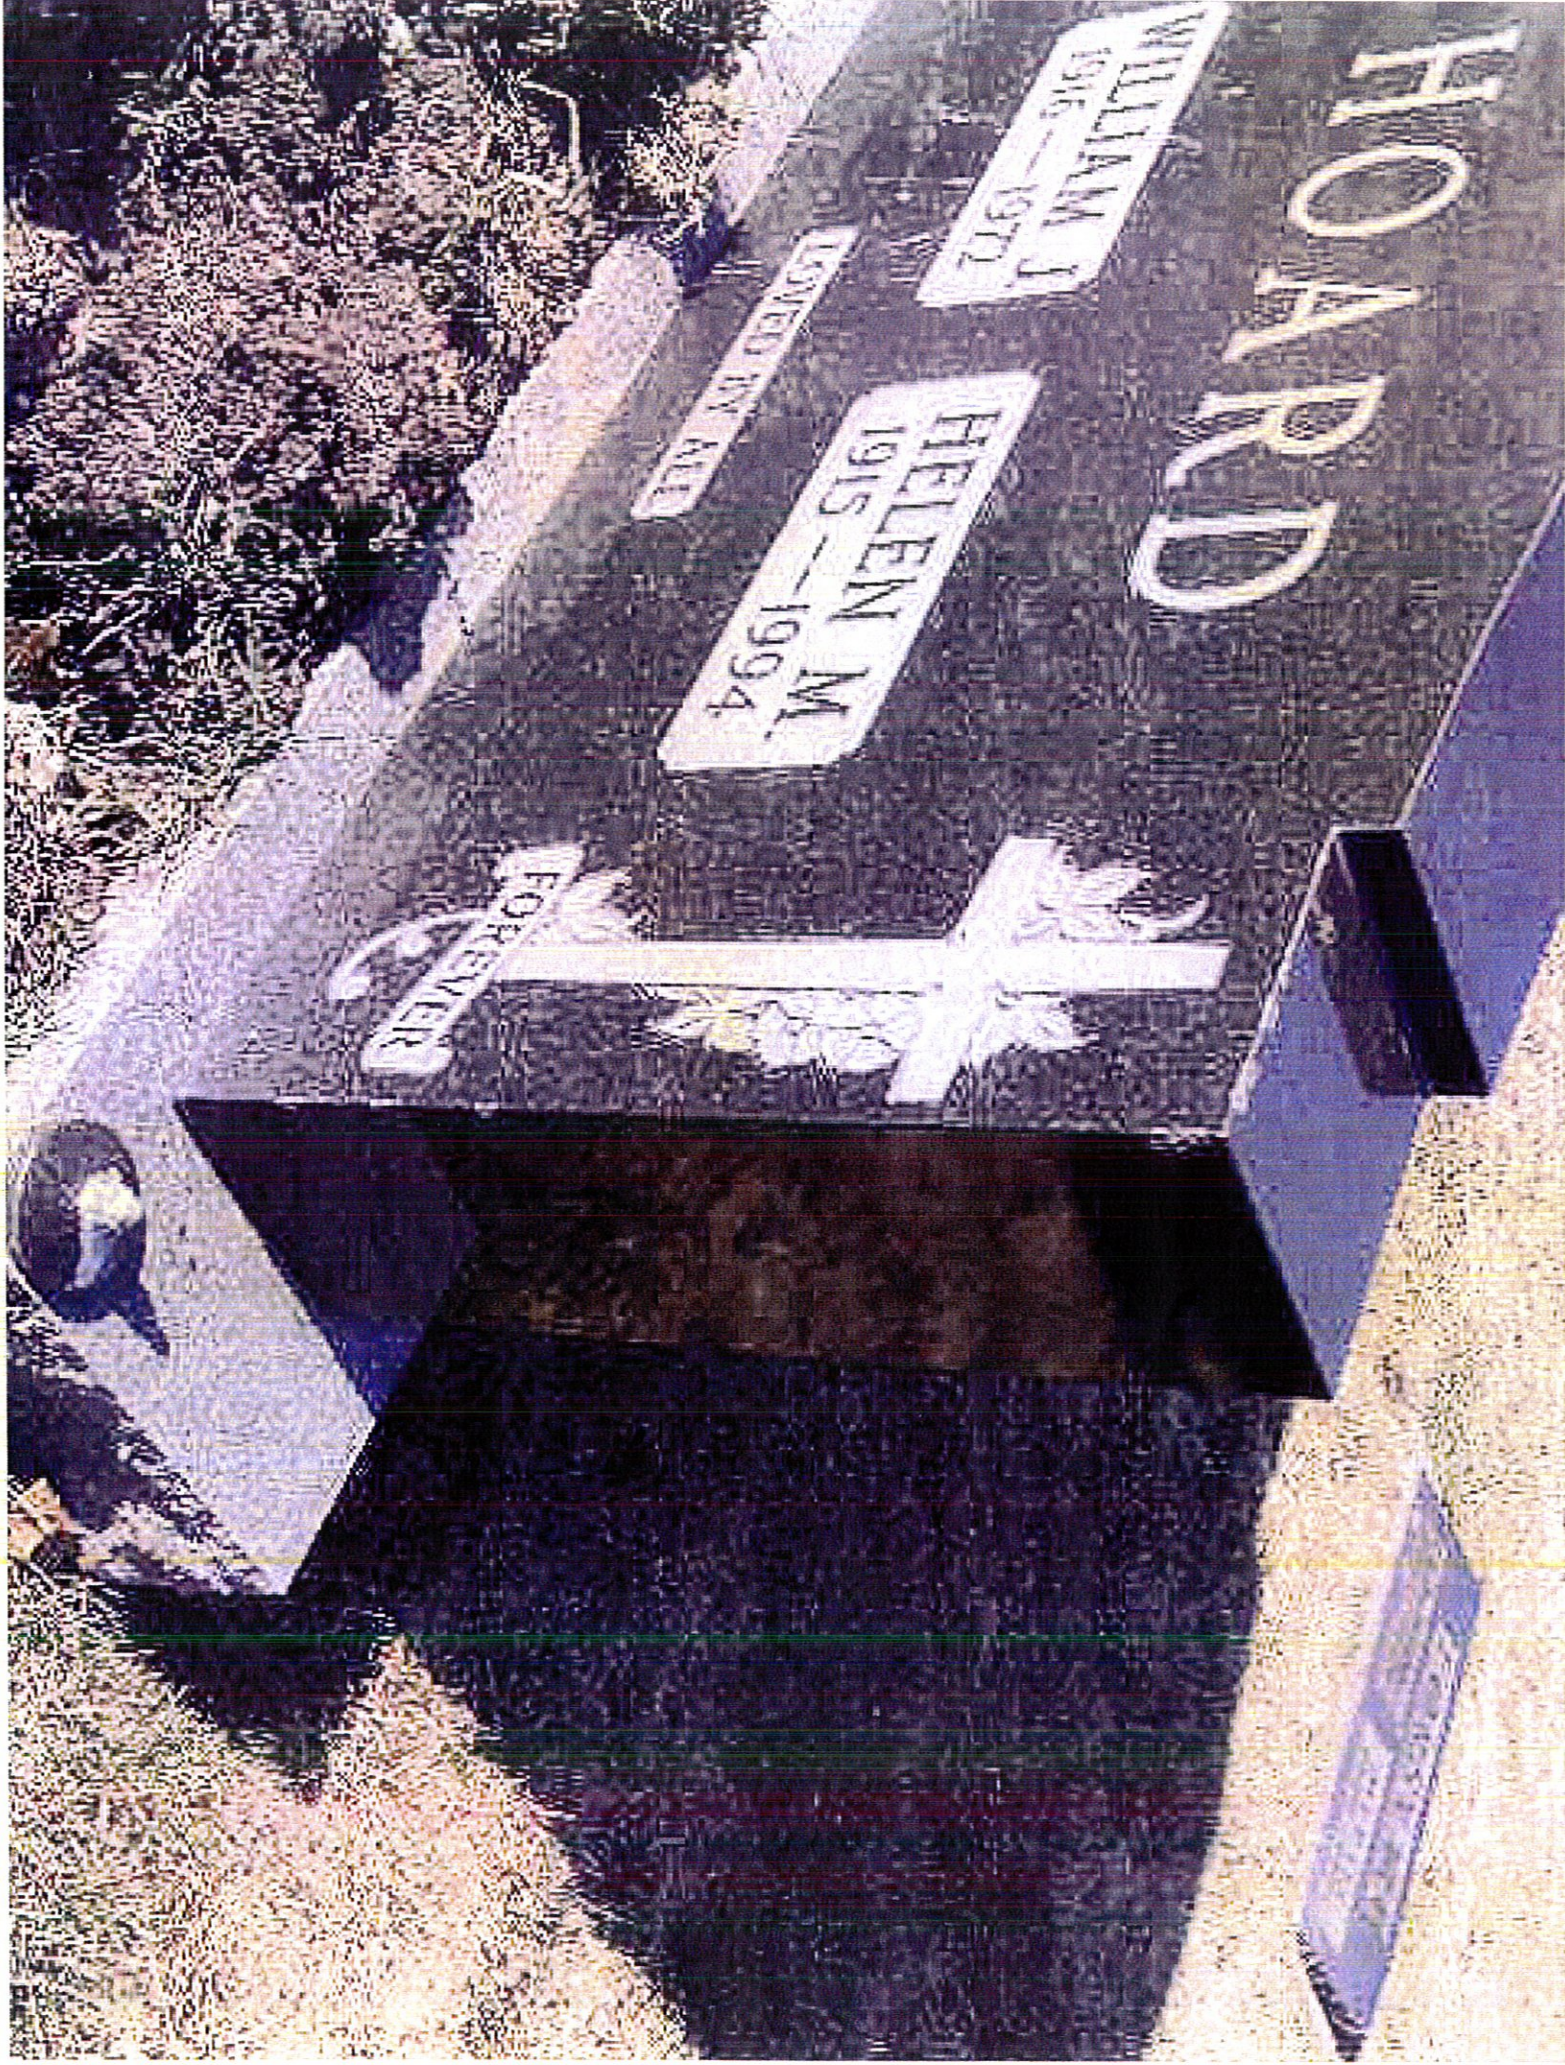
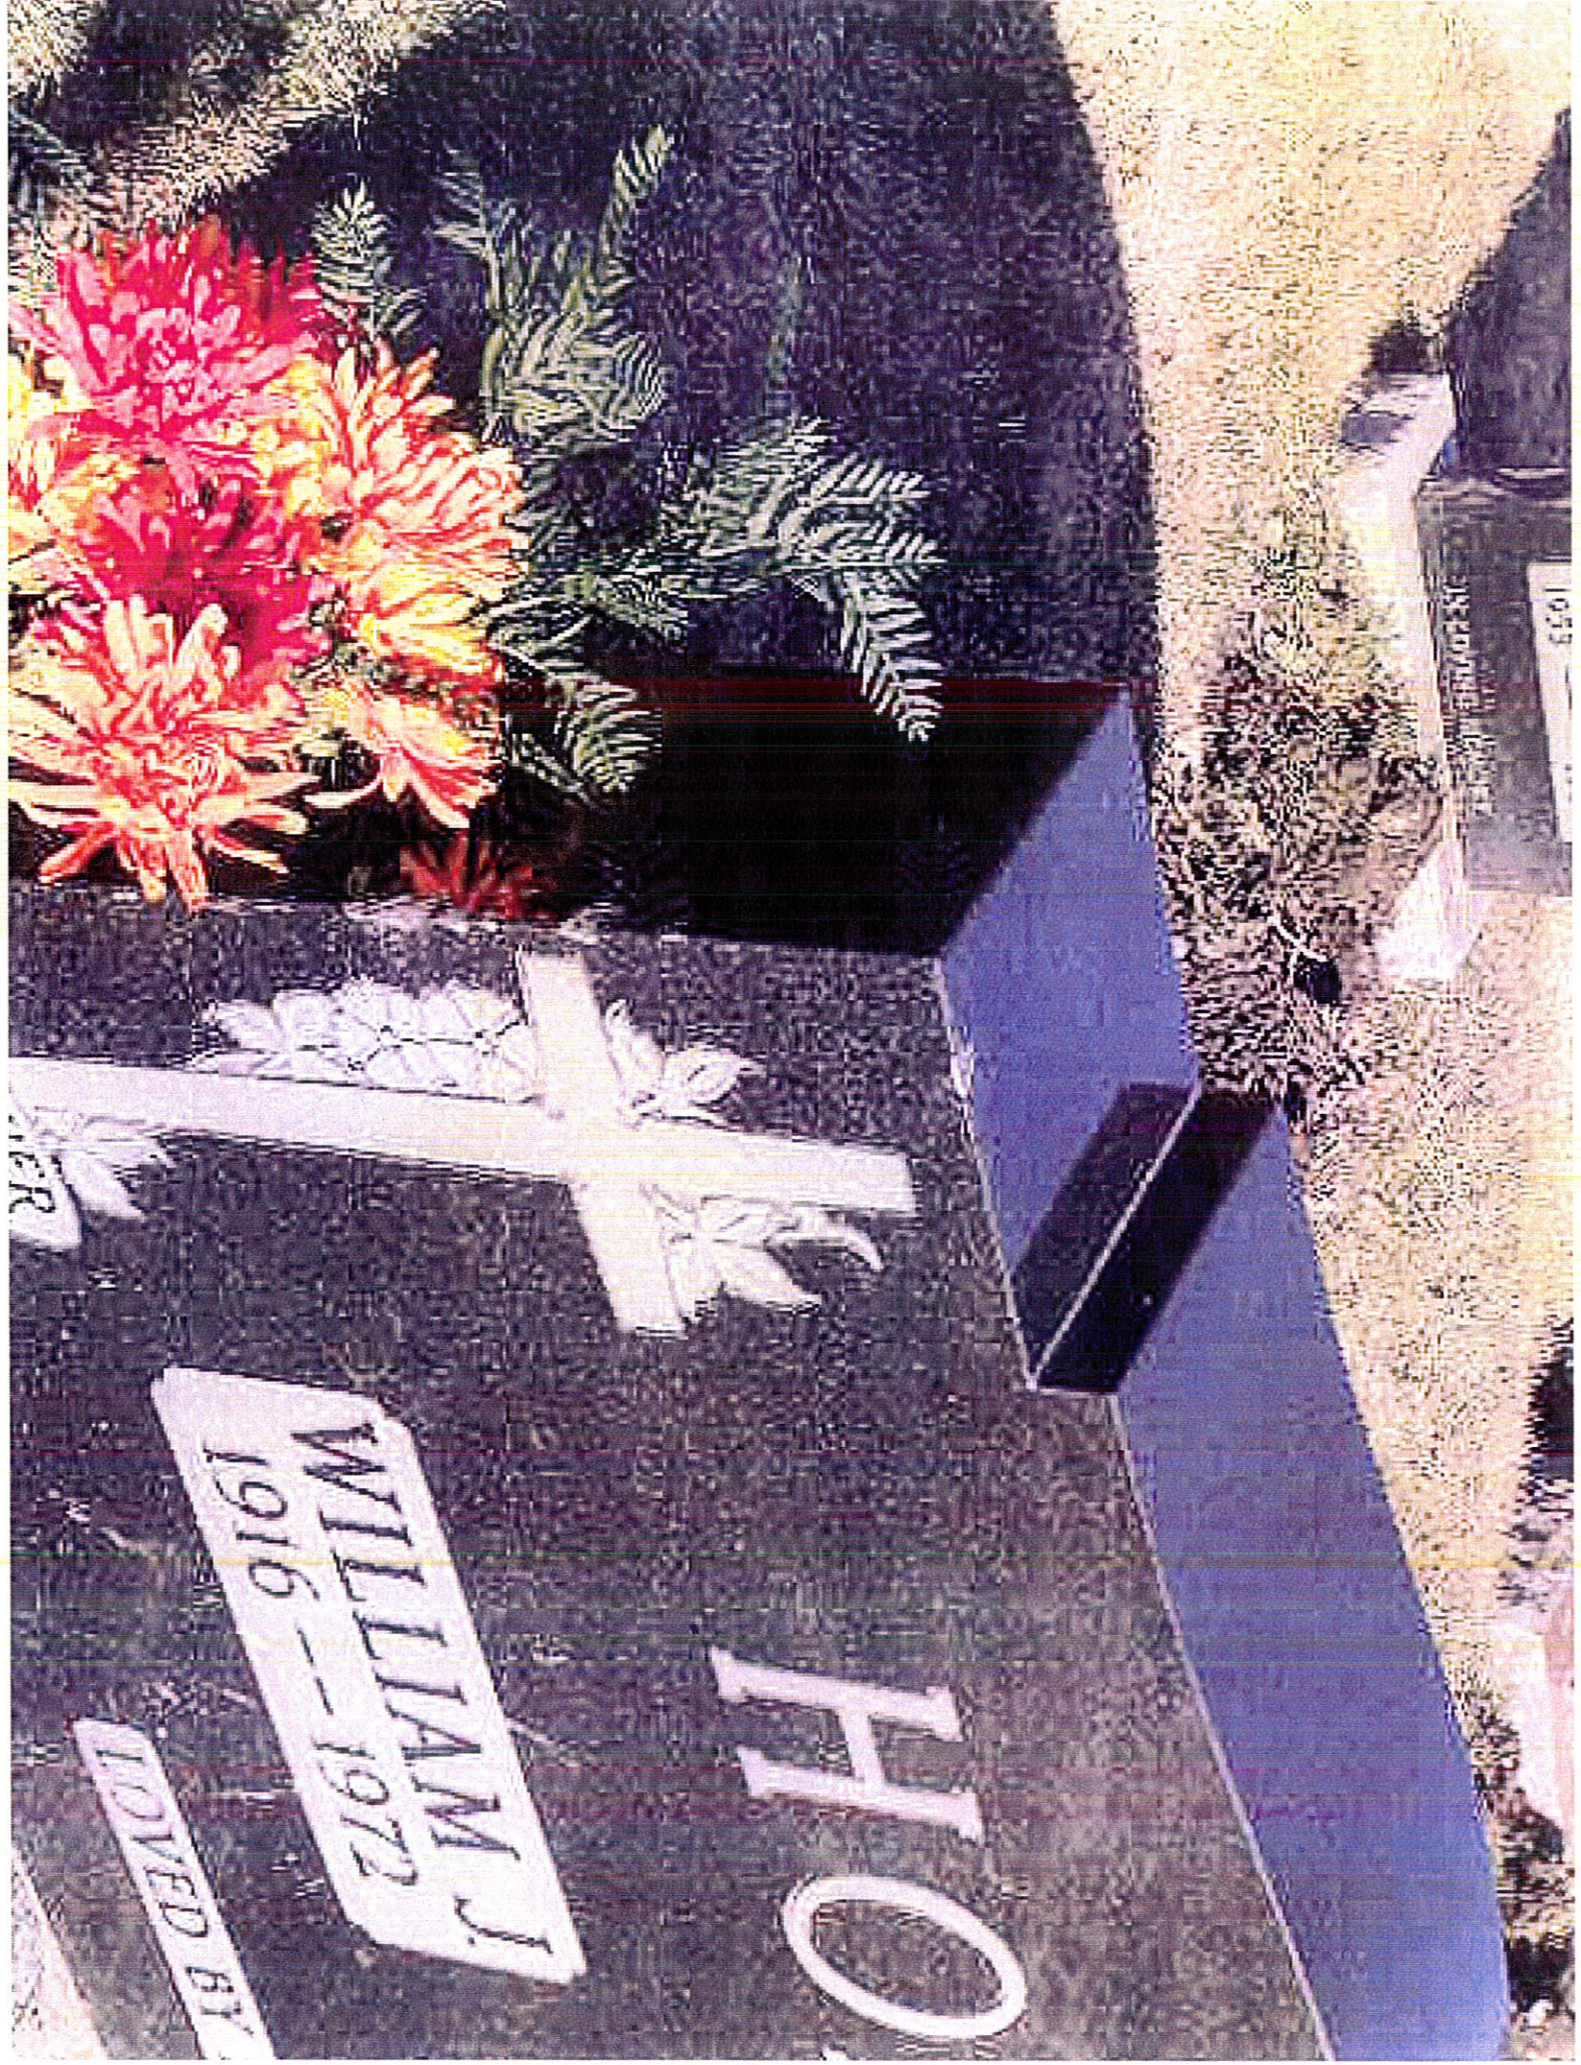
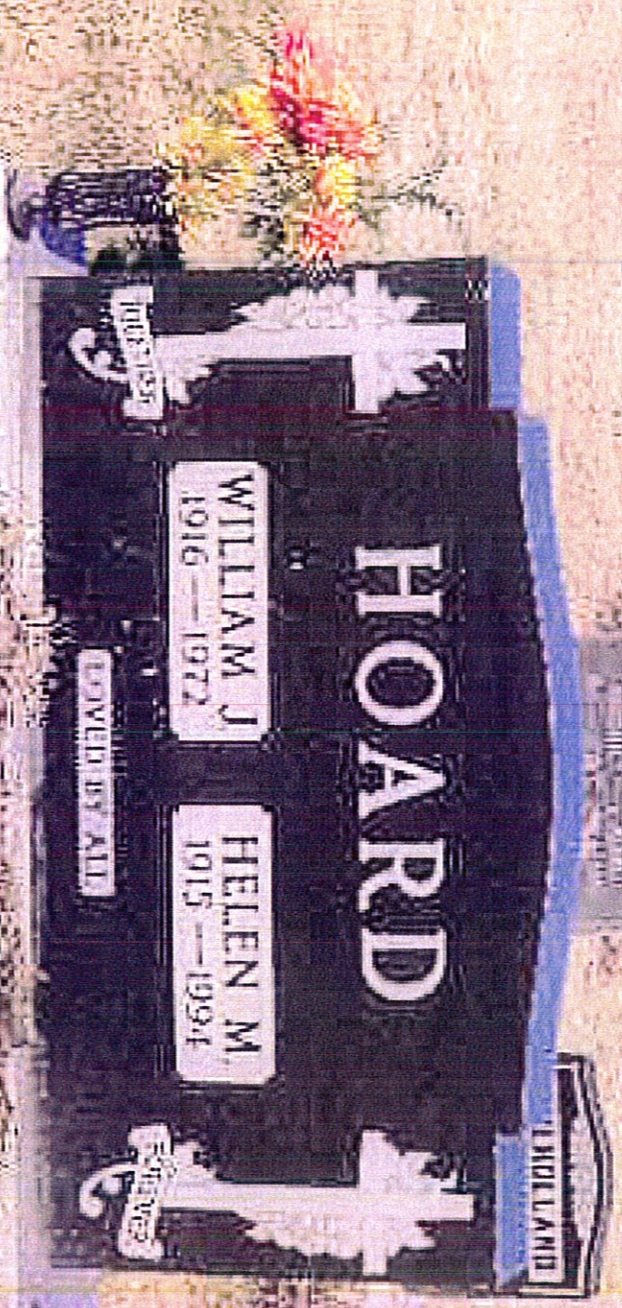
Mr. Stanley Hoard brought the damage to the headstone to administration attention in July of 2013. Please find pictures of the damage to the headstone. Mr. Hoard was given a copy of the Cemetery By-law No. 22/12 in September of 2013 where section **No. 8- Monuments and Markers** subsection 8.16 & 8.17 were pointed out to Mr. Hoard at that time. See attached pertinent subsections 8.16 & 8.17.

In discussion with Trevor McKinnon, Parks Working Foreman, the damage is quite high on the headstone other than the missing vase on the north side of the base. Thus it is difficult to correlate the damage to normal lawn care and flower bedding maintenance activities. In regards to the missing vase from the base, water in the fall time is left in the vase over the winter this water freezes and splits the vase where eventually it breaks away from the base. This is a common occurrence with vases in the cemetery. No monument or head stone setting contractor has reported damaging the Hoard family headstone in the past five years.

I am no expert in manufacturing granite or marble headstones, but it appears that the edging of the headstone (cornering) is very smooth with nominal beveling and that chips of granite were displaced. Most of the newer headstones have rougher beveled corners, thus less chance of a chipping issue. I don't know for sure but the freeze –thaw action of water could have had an impact on the damage if there was an imperfection in the granite headstone material.

- 1) Bevel all four corners and transport - \$2600 HST included.
- 2) To cut down, reduce the size of all edges and transport - \$3500 HST included
- 3) To replace with new stone and install new stone - \$7520 HST included.

- 1) That Administration meet & discuss repair and replacement options with Stan Hoard in regards to the Hoard family headstone damages as per quotation supplied by Brunet Monuments Inc. & Lakehead Monuments.
- 2) That Council authorize administration to utilize one of the three repair or replacement options in regards to the Hoard Family headstone and that the selected option be funded out of the Cemetery Care and Maintenance Reserve Funds.
