Report To: Mayor and Council

**RE: Sewage Backup – 509 Victoria Avenue**

Report To: Travis Rob, Manager of Operations & Facilities  
From: Douglas Herr, Environmental & Facilities Superintendent  
**SUBJECT: Sewage Backup**  
**509 Victoria Avenue (Heather & Geoff MacEachern)**  
**Letter Dated: October, 2016**

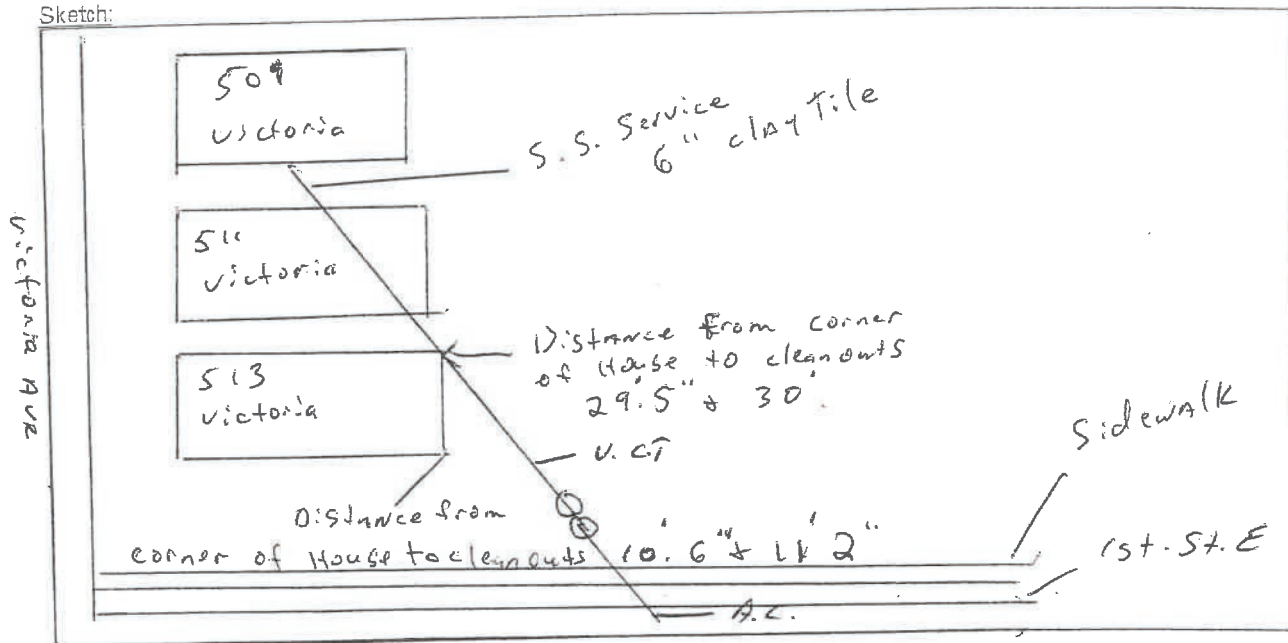
Sketch:

Location: Civic Address: 509 & 511 Victoria Ave  
Frontage/Flankage Street: Service goes out back to 1st St. E.

House address that service is branched off of: 509, 511 are all serviced off of one

Other (Specify): A.C. from property to main, V.C.T. from property to houses.

Length of Service (Main to Cleanout): \_\_\_\_\_ metres  
Length of Repair Section: 121" metres Location of Repair: \_\_\_\_\_  
Repair Information: From property out towards main  
installed clean out towards main & towards  
Houses, P.U.C. & 2 Fernco's.
