TOWN OF FORT FRANCES
East End Sanitary Sewer Study
Final Report

October 2, 2017

H-354684

Subject: East End Sanitary Sewer Study

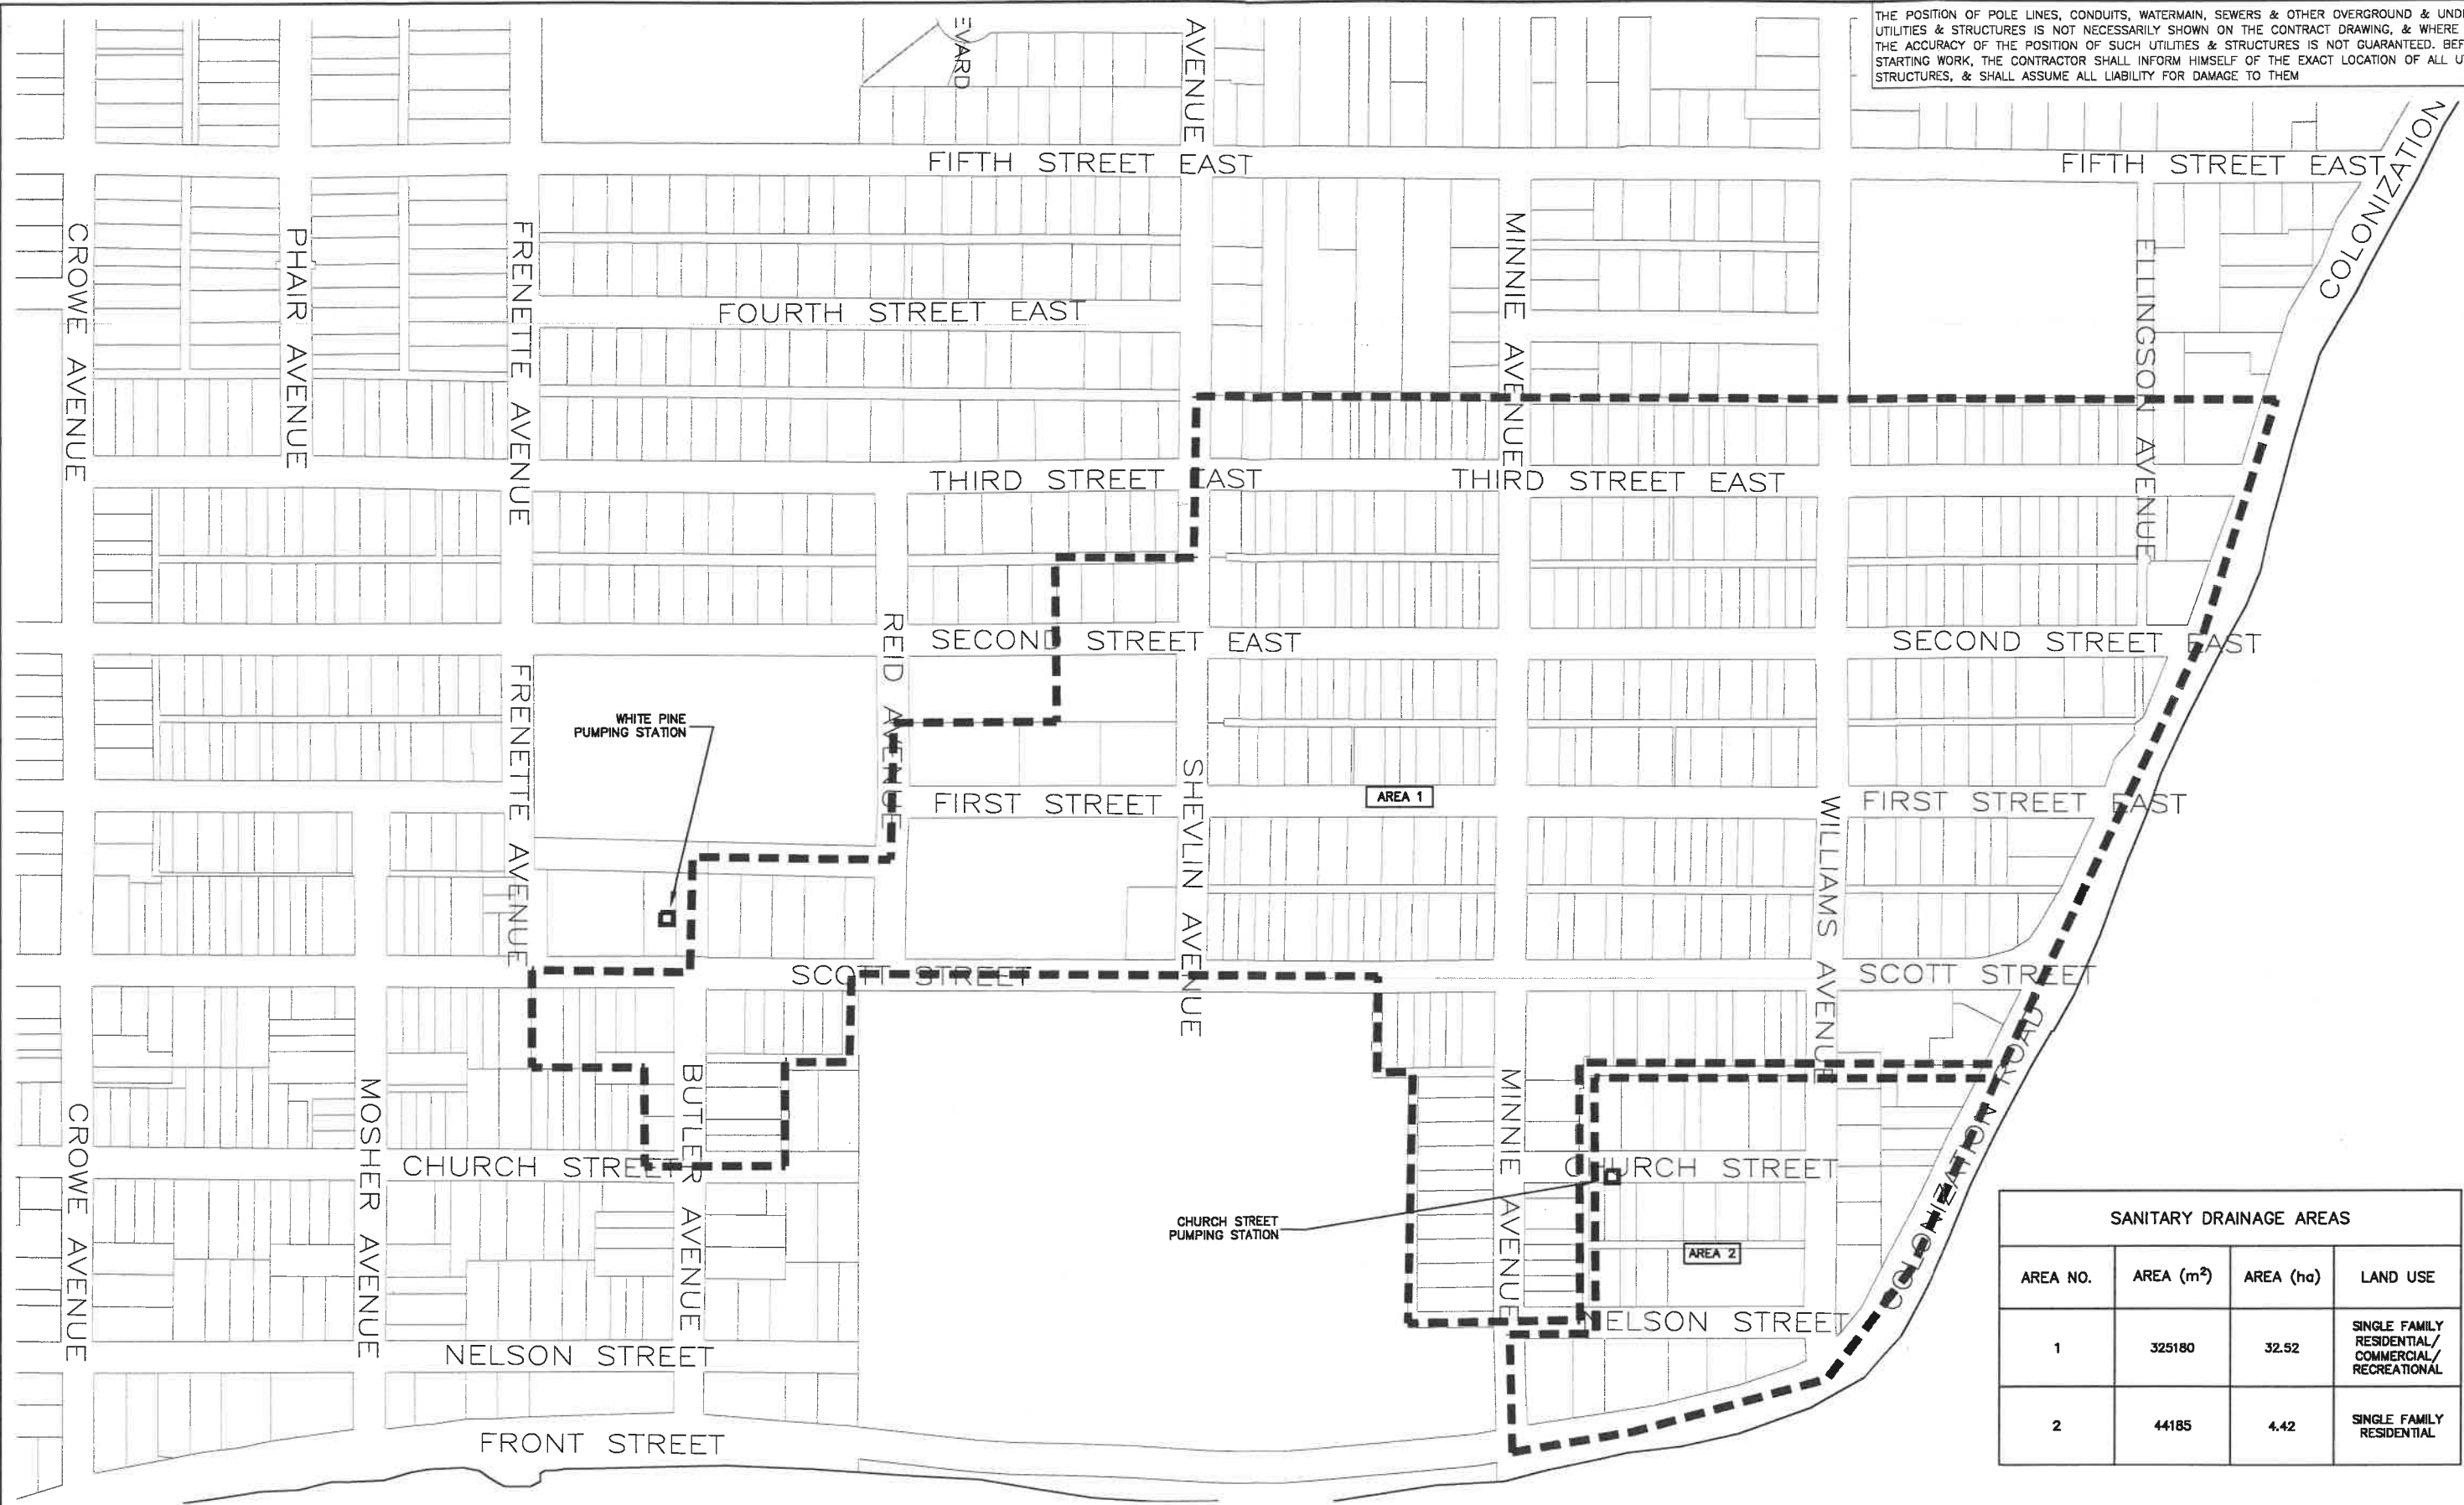
Drawing A1-354684-D1 illustrates the locations of the Church Street and White Pine Pumping Stations and their respective drainage areas.

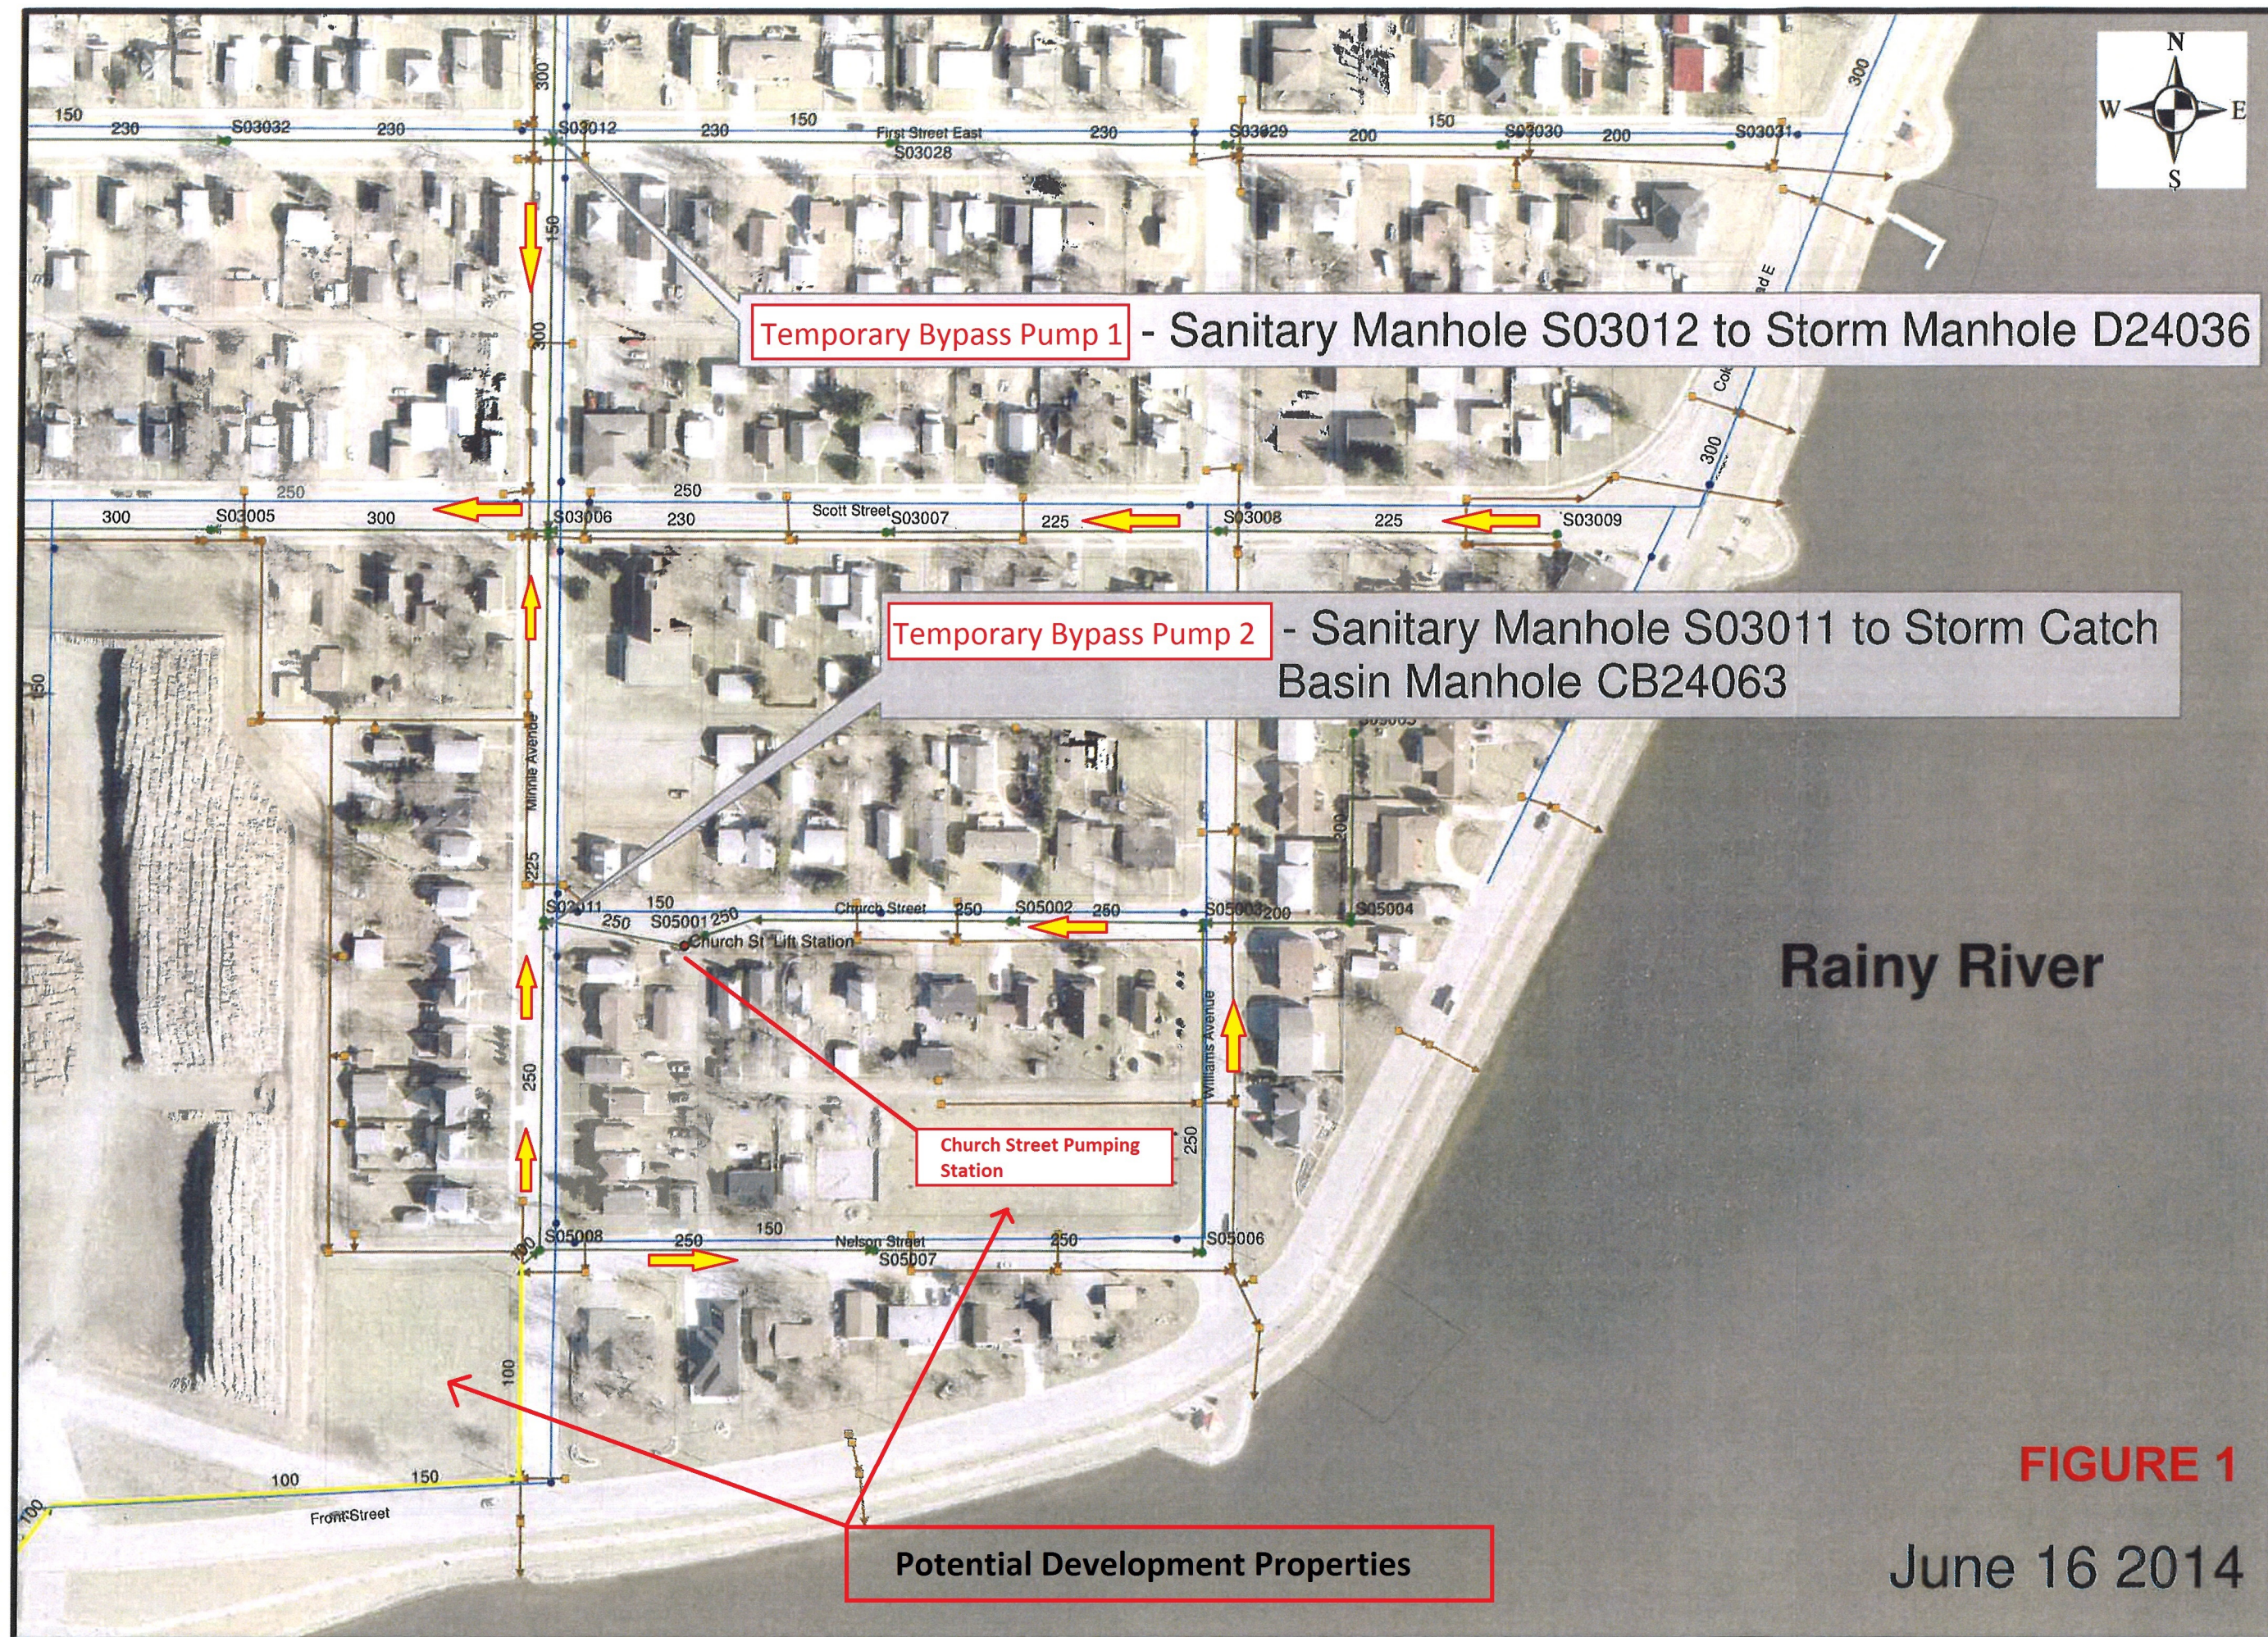
FIGURE 1

Reports of basement flooding in the Church Street, Minnie Avenue, Nelson Street area began to come in and the Public Works Department setup one pump at the intersection of Minnie Avenue and Nelson Street to pump from the sanitary sewer into the storm sewer. This was not having much effect so a second pump was setup at 2:36 pm. This was still not having a significant effect so a third pump was setup at First Street East and Minnie Avenue at 5:58 pm. This was having a very positive effect so one pump at Minnie Avenue and Nelson Street was shut down at 6:30 pm and the second pump at 10:00 pm. The pump at Minnie Avenue and First Street East operated over night and was shut down at 8:40 am on the morning of June 13, 2014. An estimated volume of 2276 cubic metres was pumped from the sanitary sewer into the storm sewer during this period. **Figure 1** shows the by-pass pumping locations.

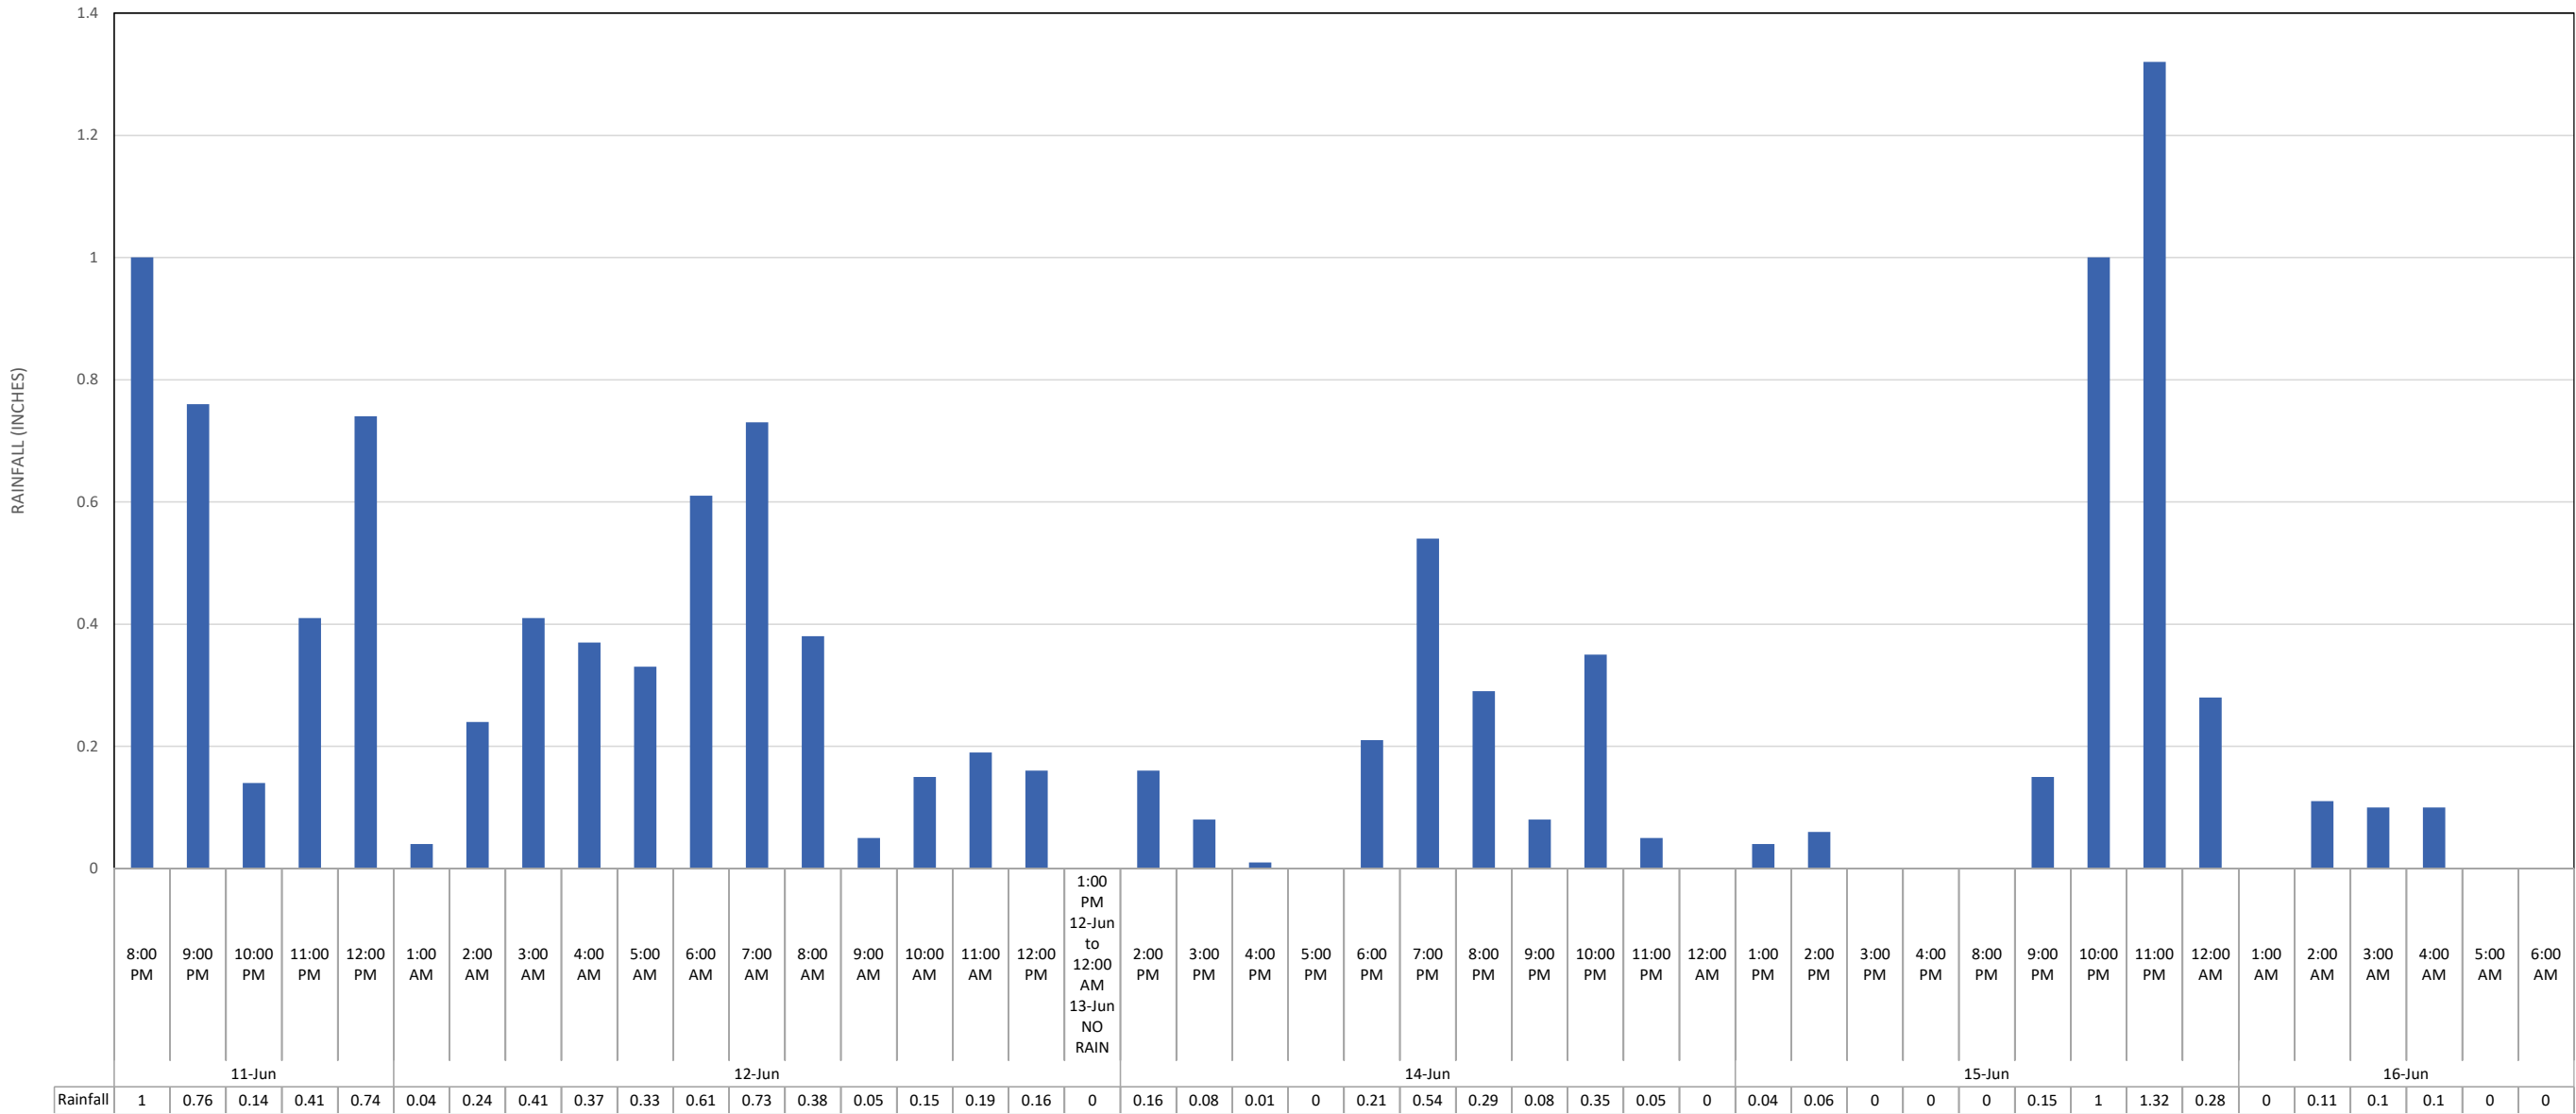
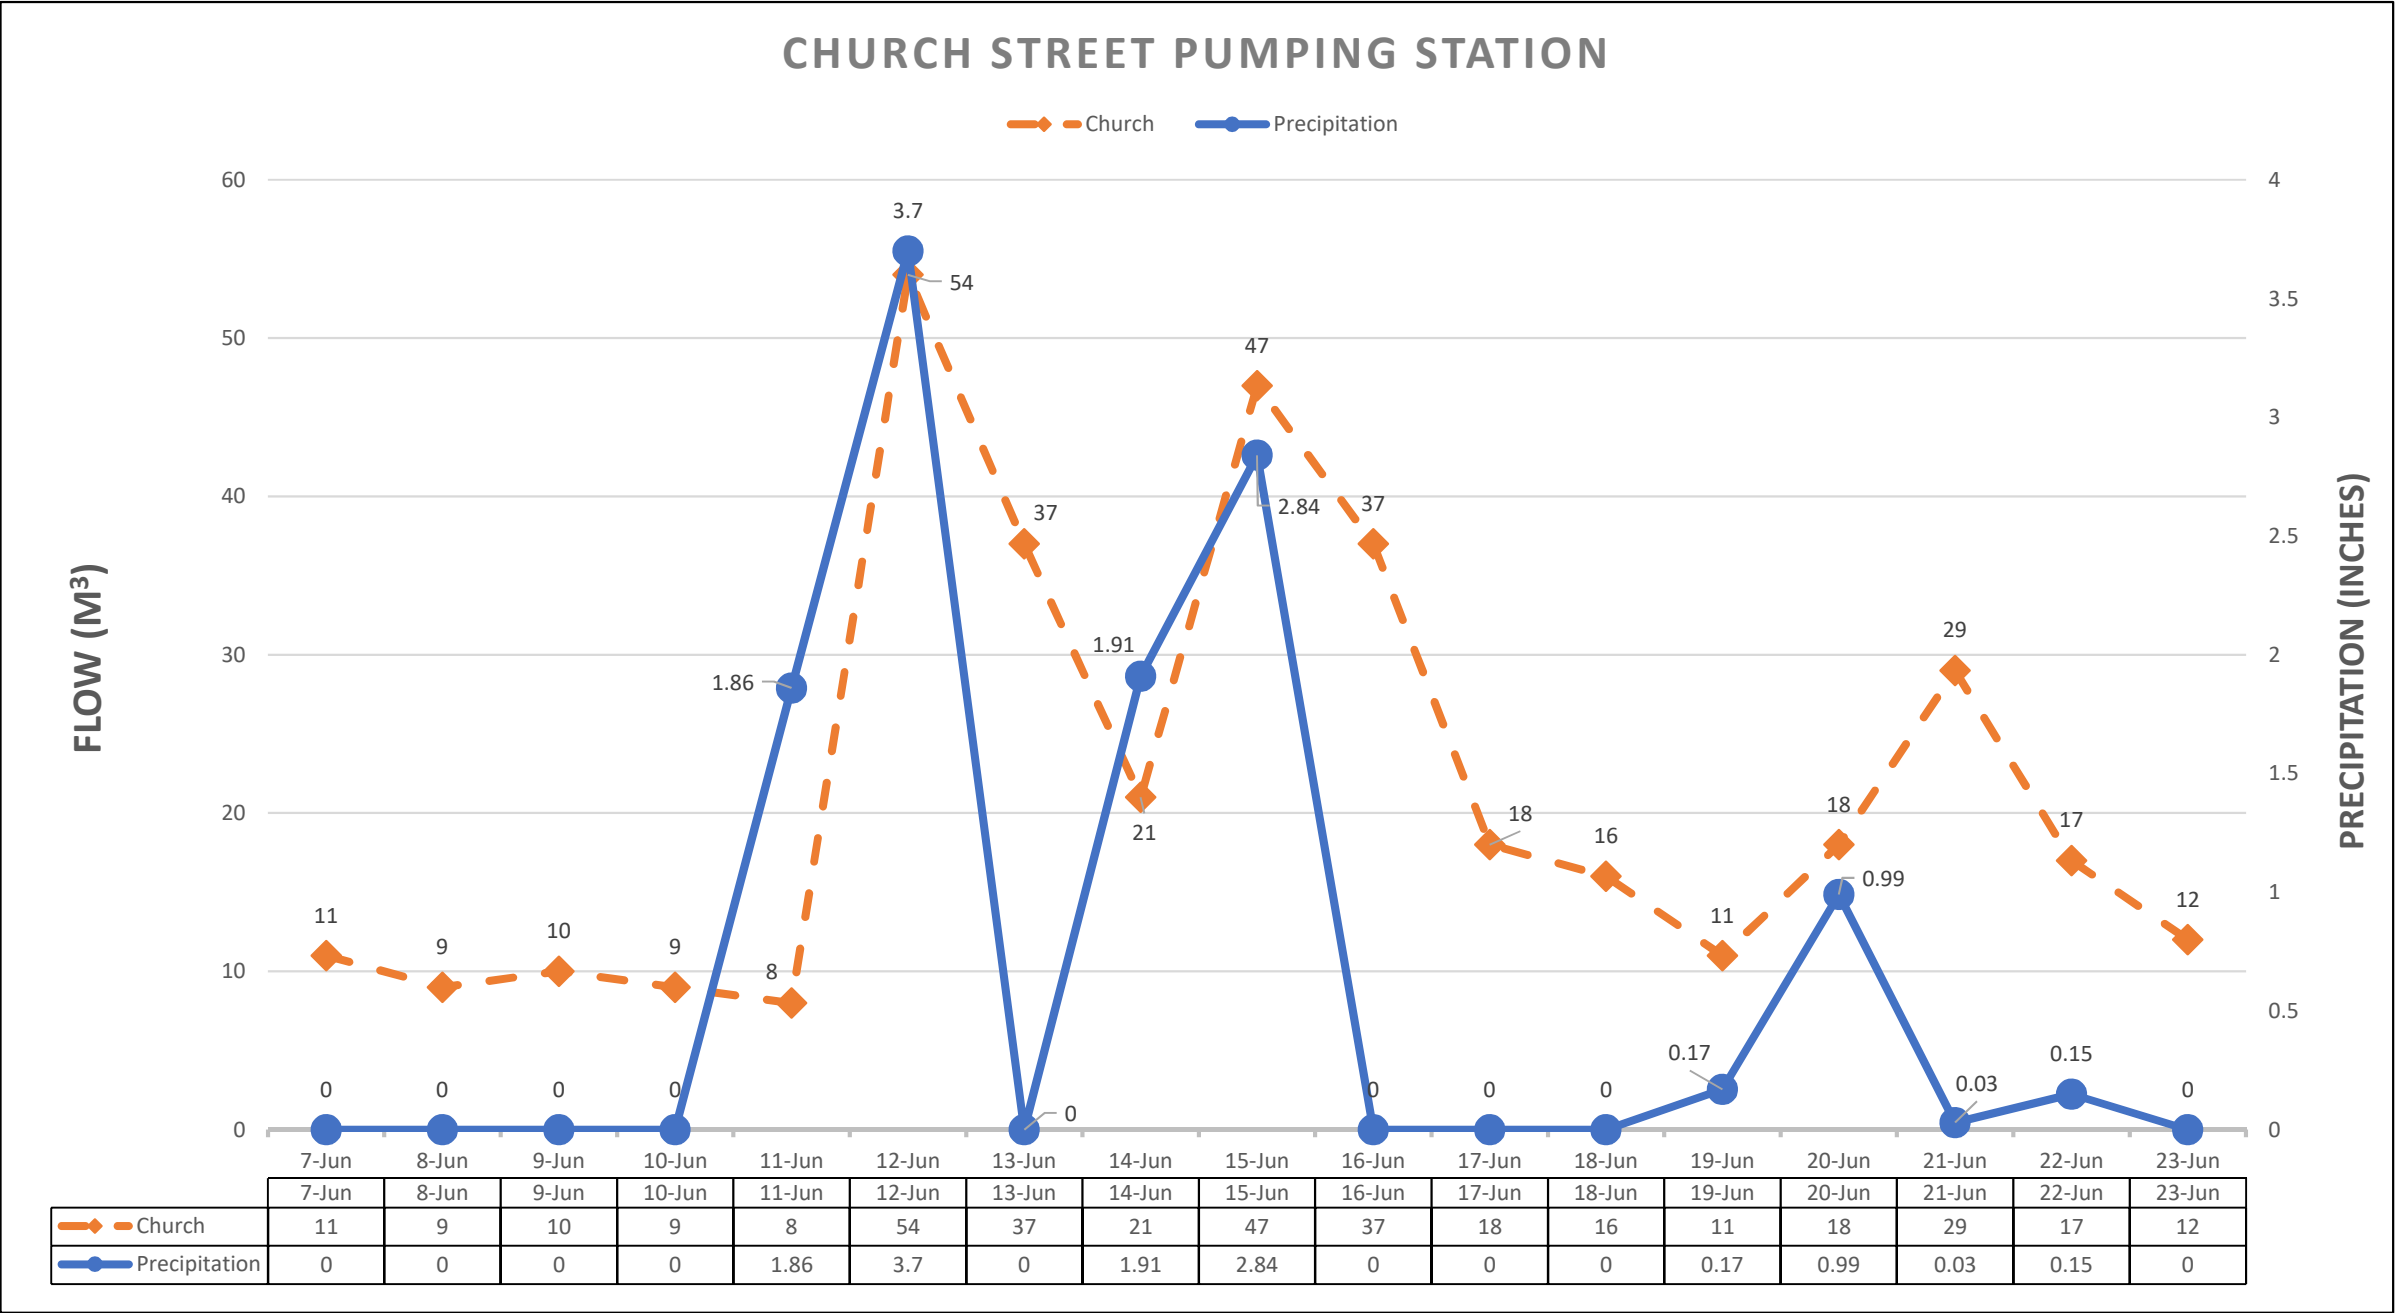
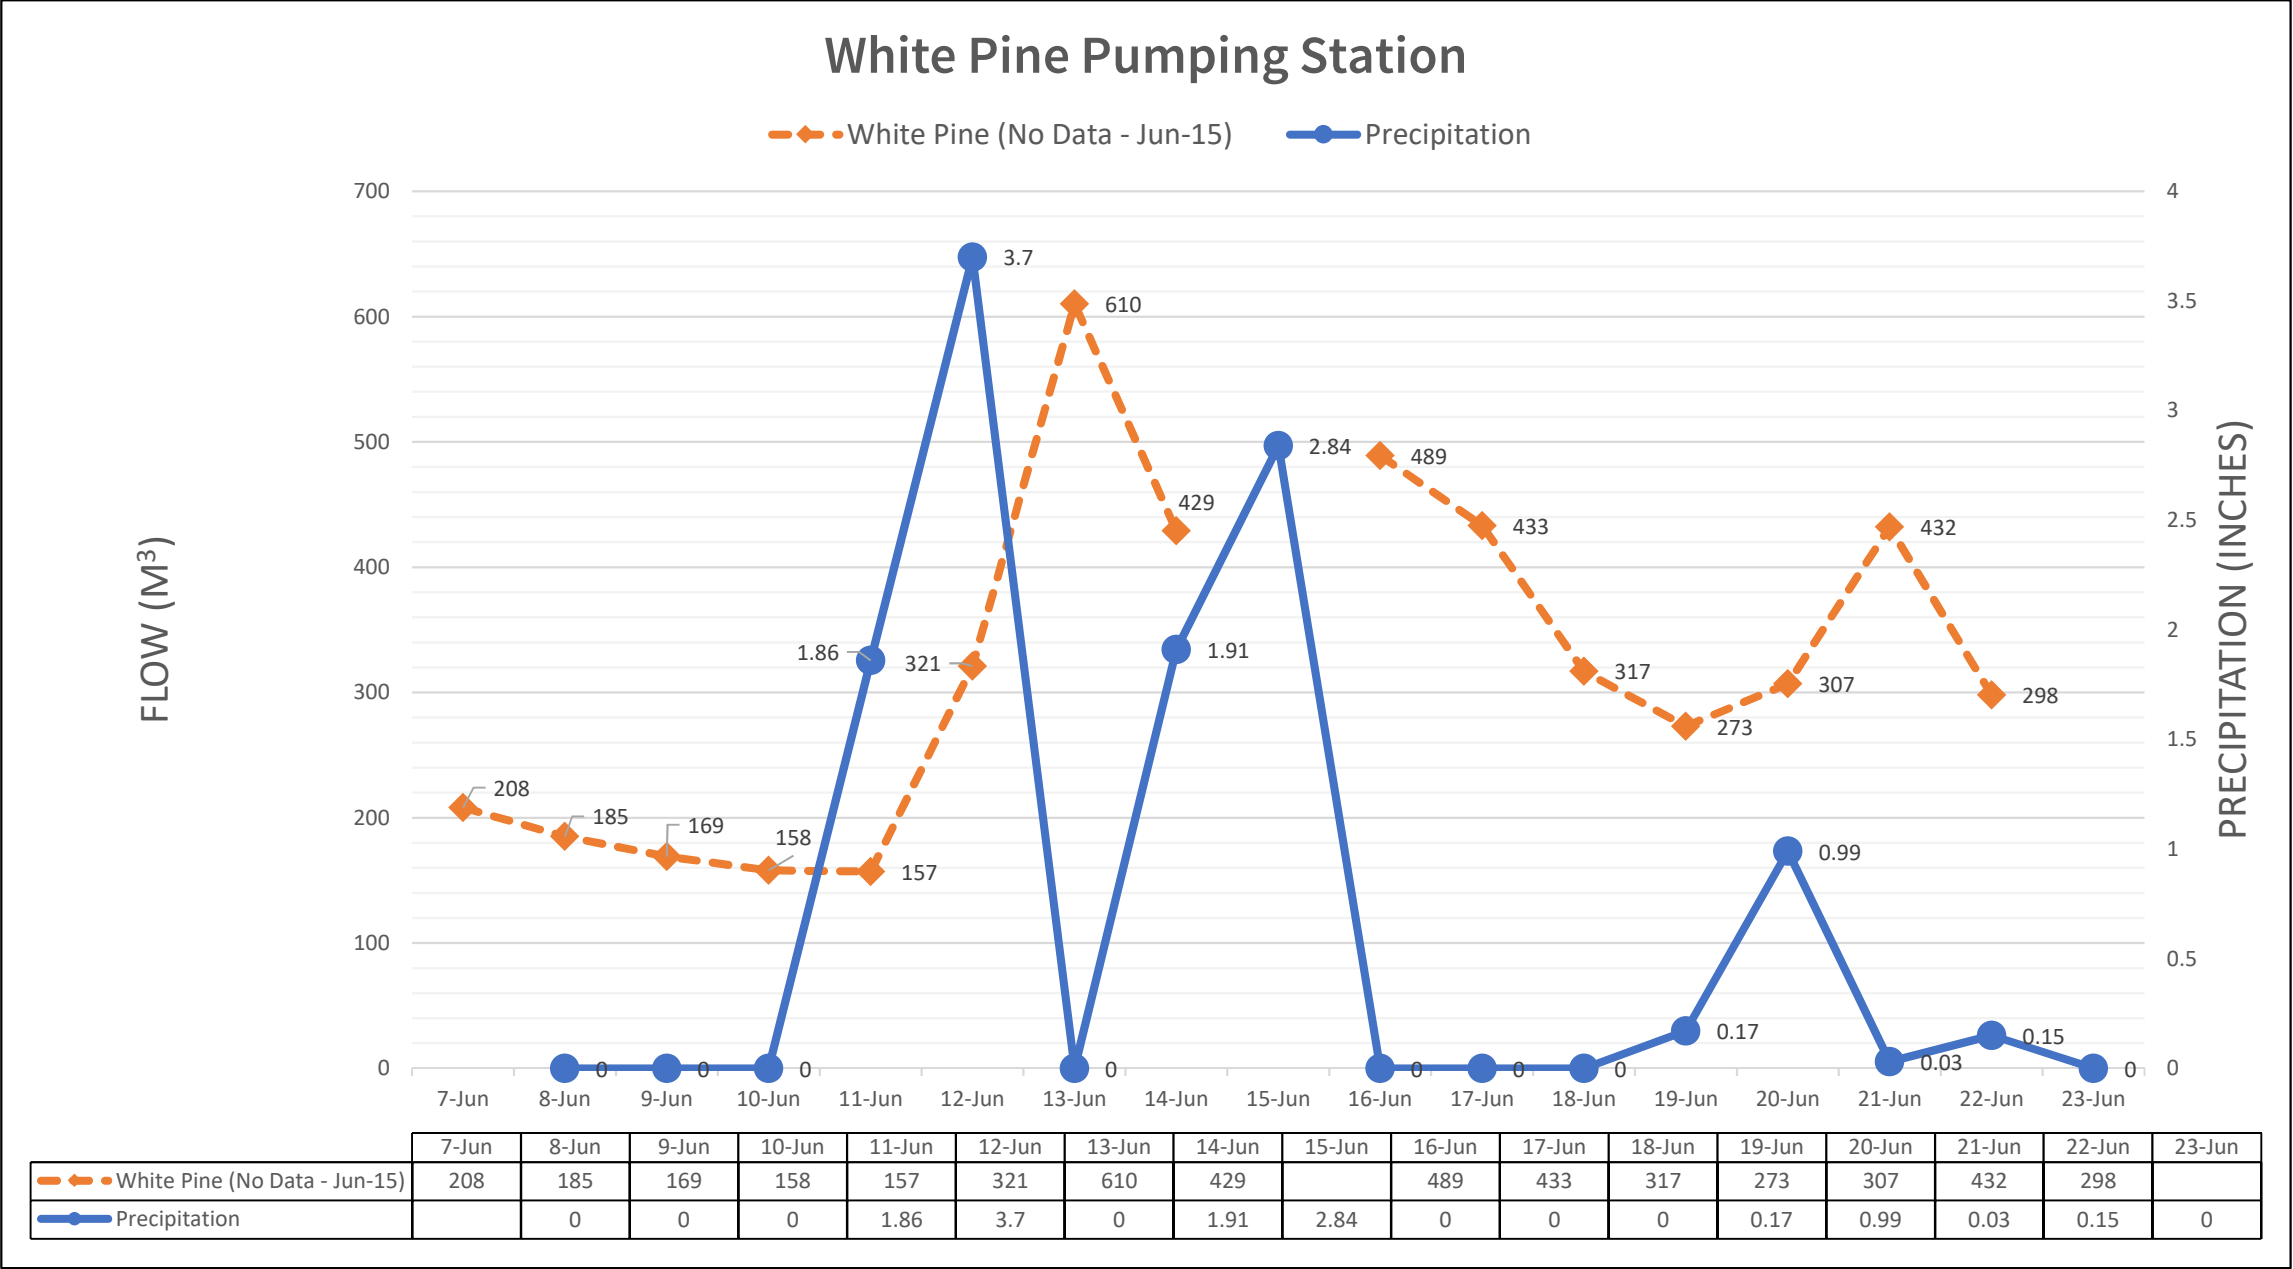
Town of Fort Frances
East End Sanitary Sewer Study
Rainfall Record
(from International Falls Met Station)
No Rainfall from 1:00pm June 12 to 12:00am June 13

From the two pumping stations graphs it is apparent that the increase in the flow at the stations occurs fairly quickly (within 24 hours) after the rain events and decreases quickly as well.

A reaction of this nature is normally considered to be the result of inflow from direct connections to the sewer (though manholes, sump pumps and downspouts) and through weeping tile systems that have a good connection to the surface. The pump flow data is also affected by the by-pass pumping and probable short-circuiting in the Church Street pumping station.

However, when one compares the pump station flows for the period before the storm (June 7-11) with the flow after the storm there is a noticeable and sustained increase in flow which is considered to be due to ongoing infiltration. Both stations also show a flow spike following a rainfall event on June 20 which indicates a fairly direct connection between the ground surface and the sewer system.
