# TOWN OF FORT FRANCES

### AGENDA - October 18, 2017, 8:30 AM

## **East End Sanitary Sewer Study**

### **Final Report**

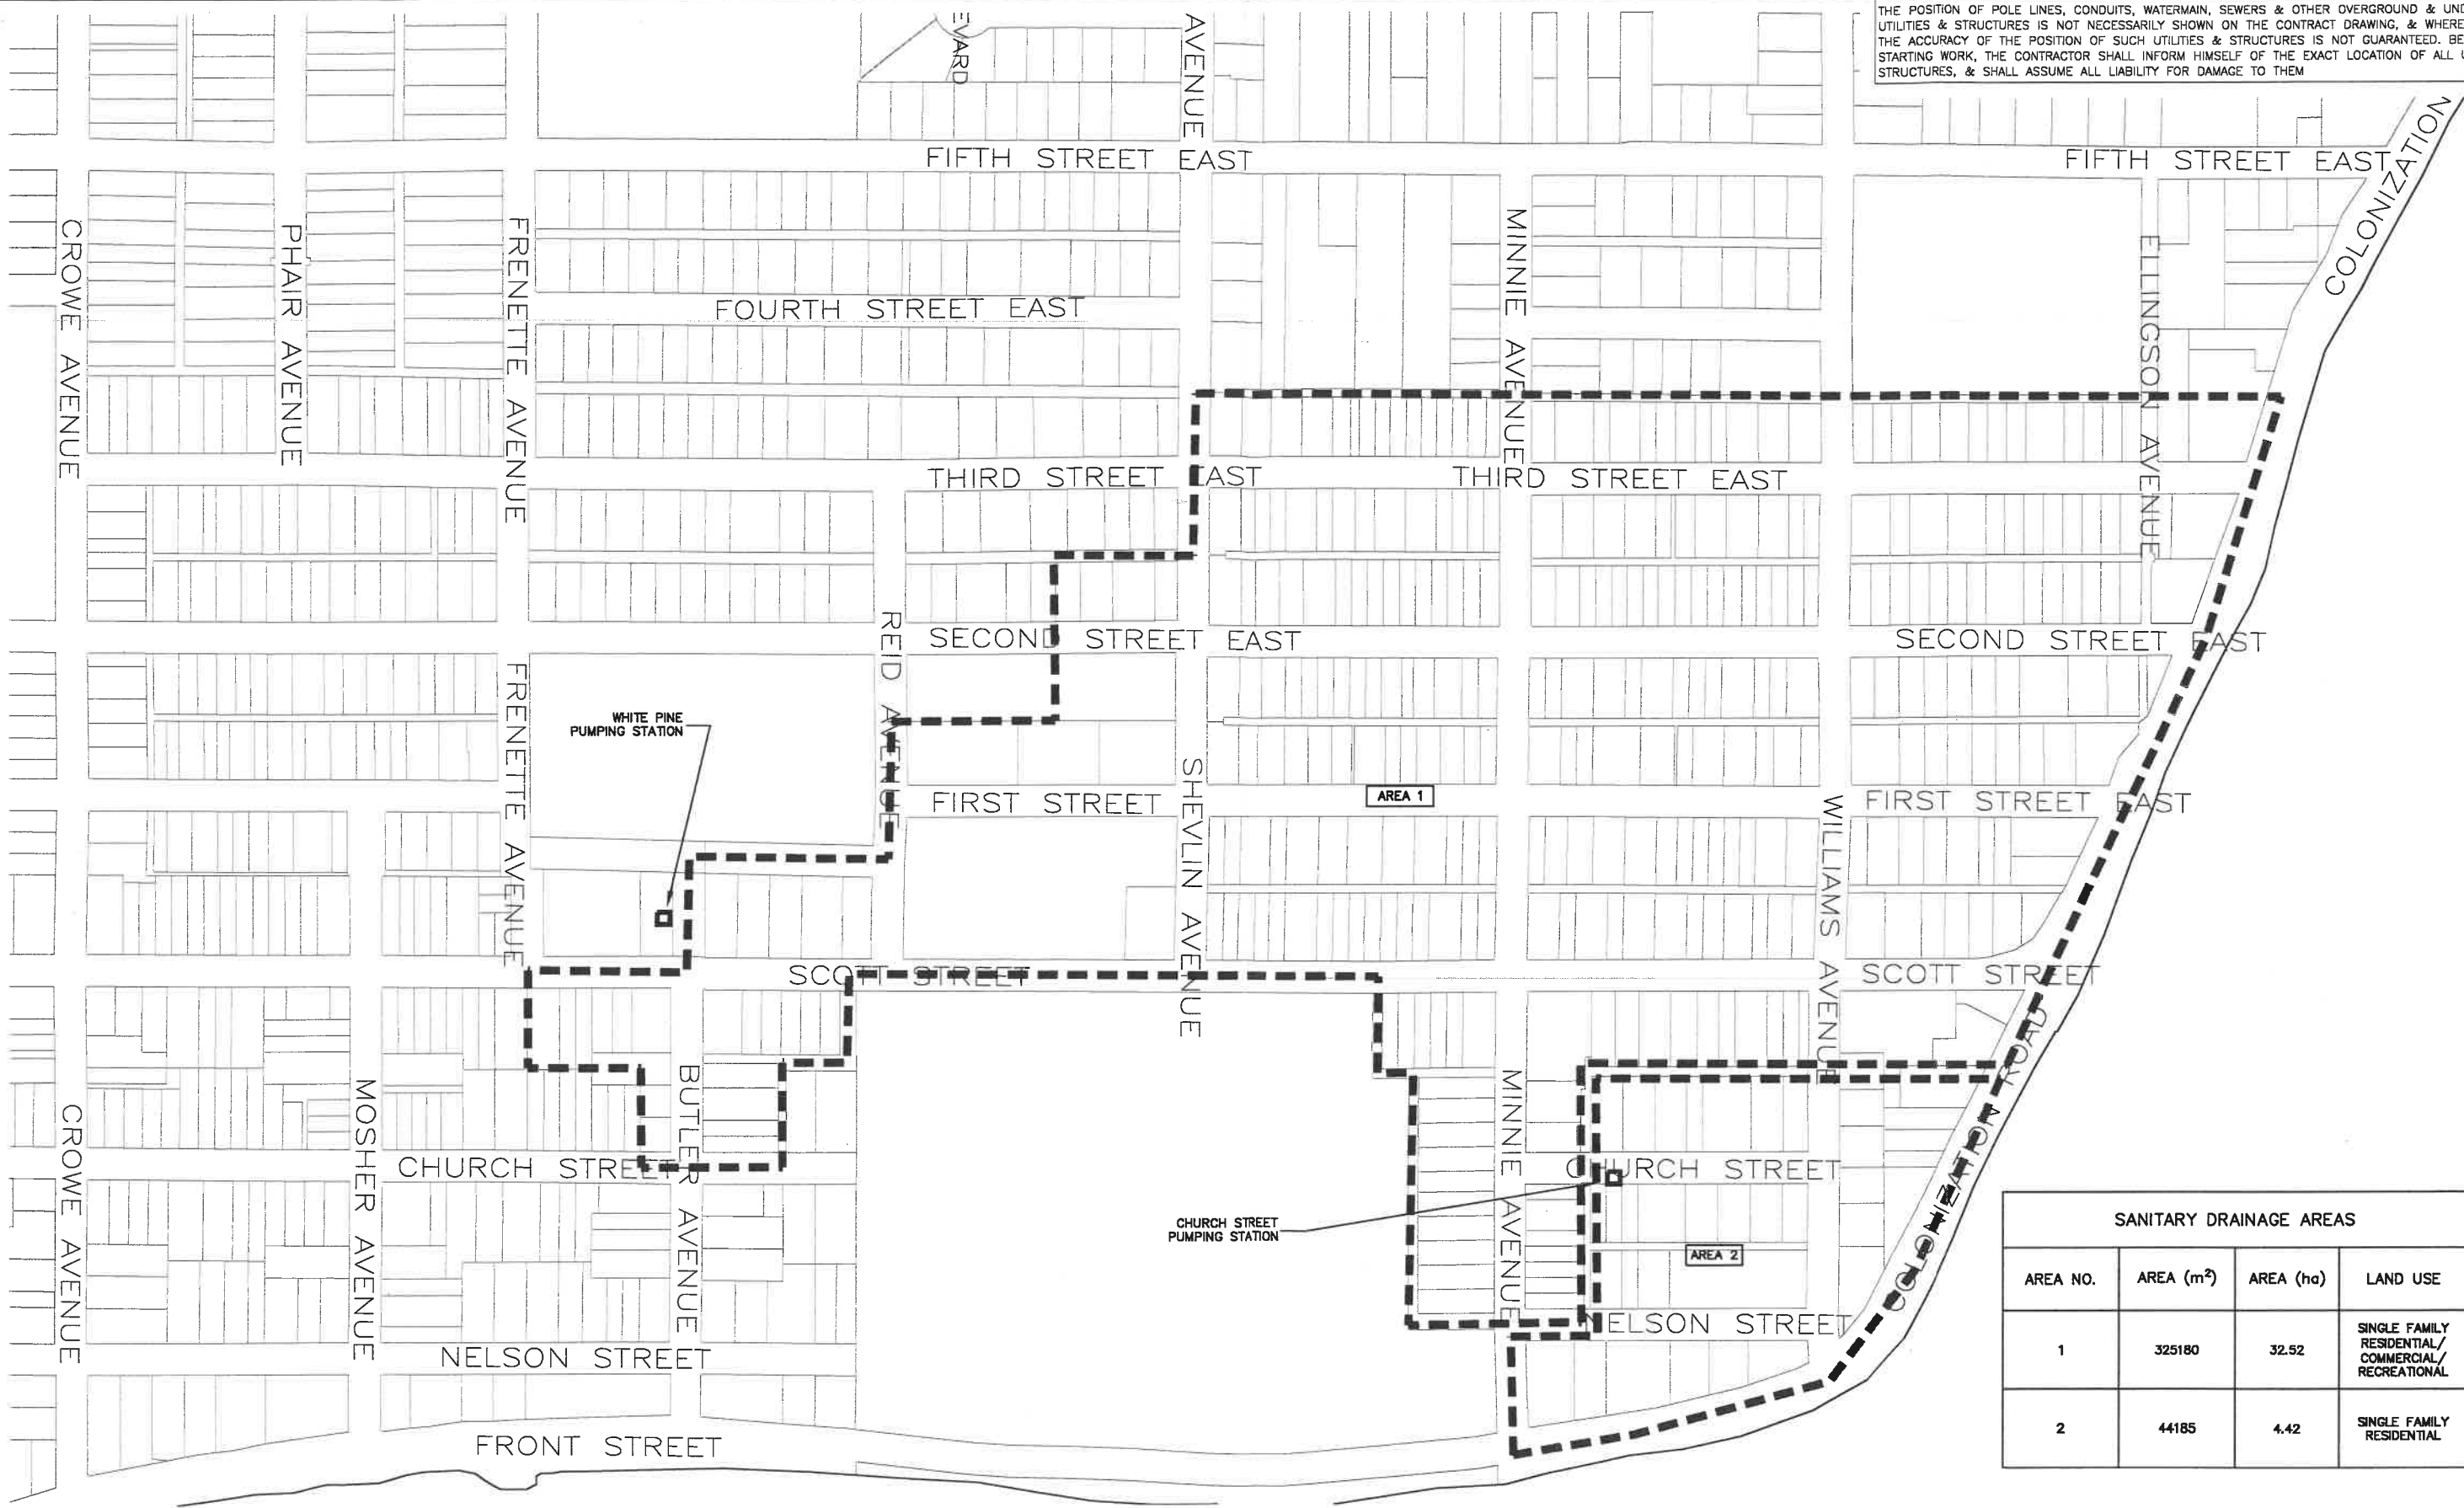
SANITARY DRAINAGE AREAS			
AREA NO.	AREA (m²)	AREA (ha)	LAND USE
1	325180	32.52	SINGLE FAMILY RESIDENTIAL/COMMERCIAL/RECREATIONAL
2	44185	4.42	SINGLE FAMILY RESIDENTIAL

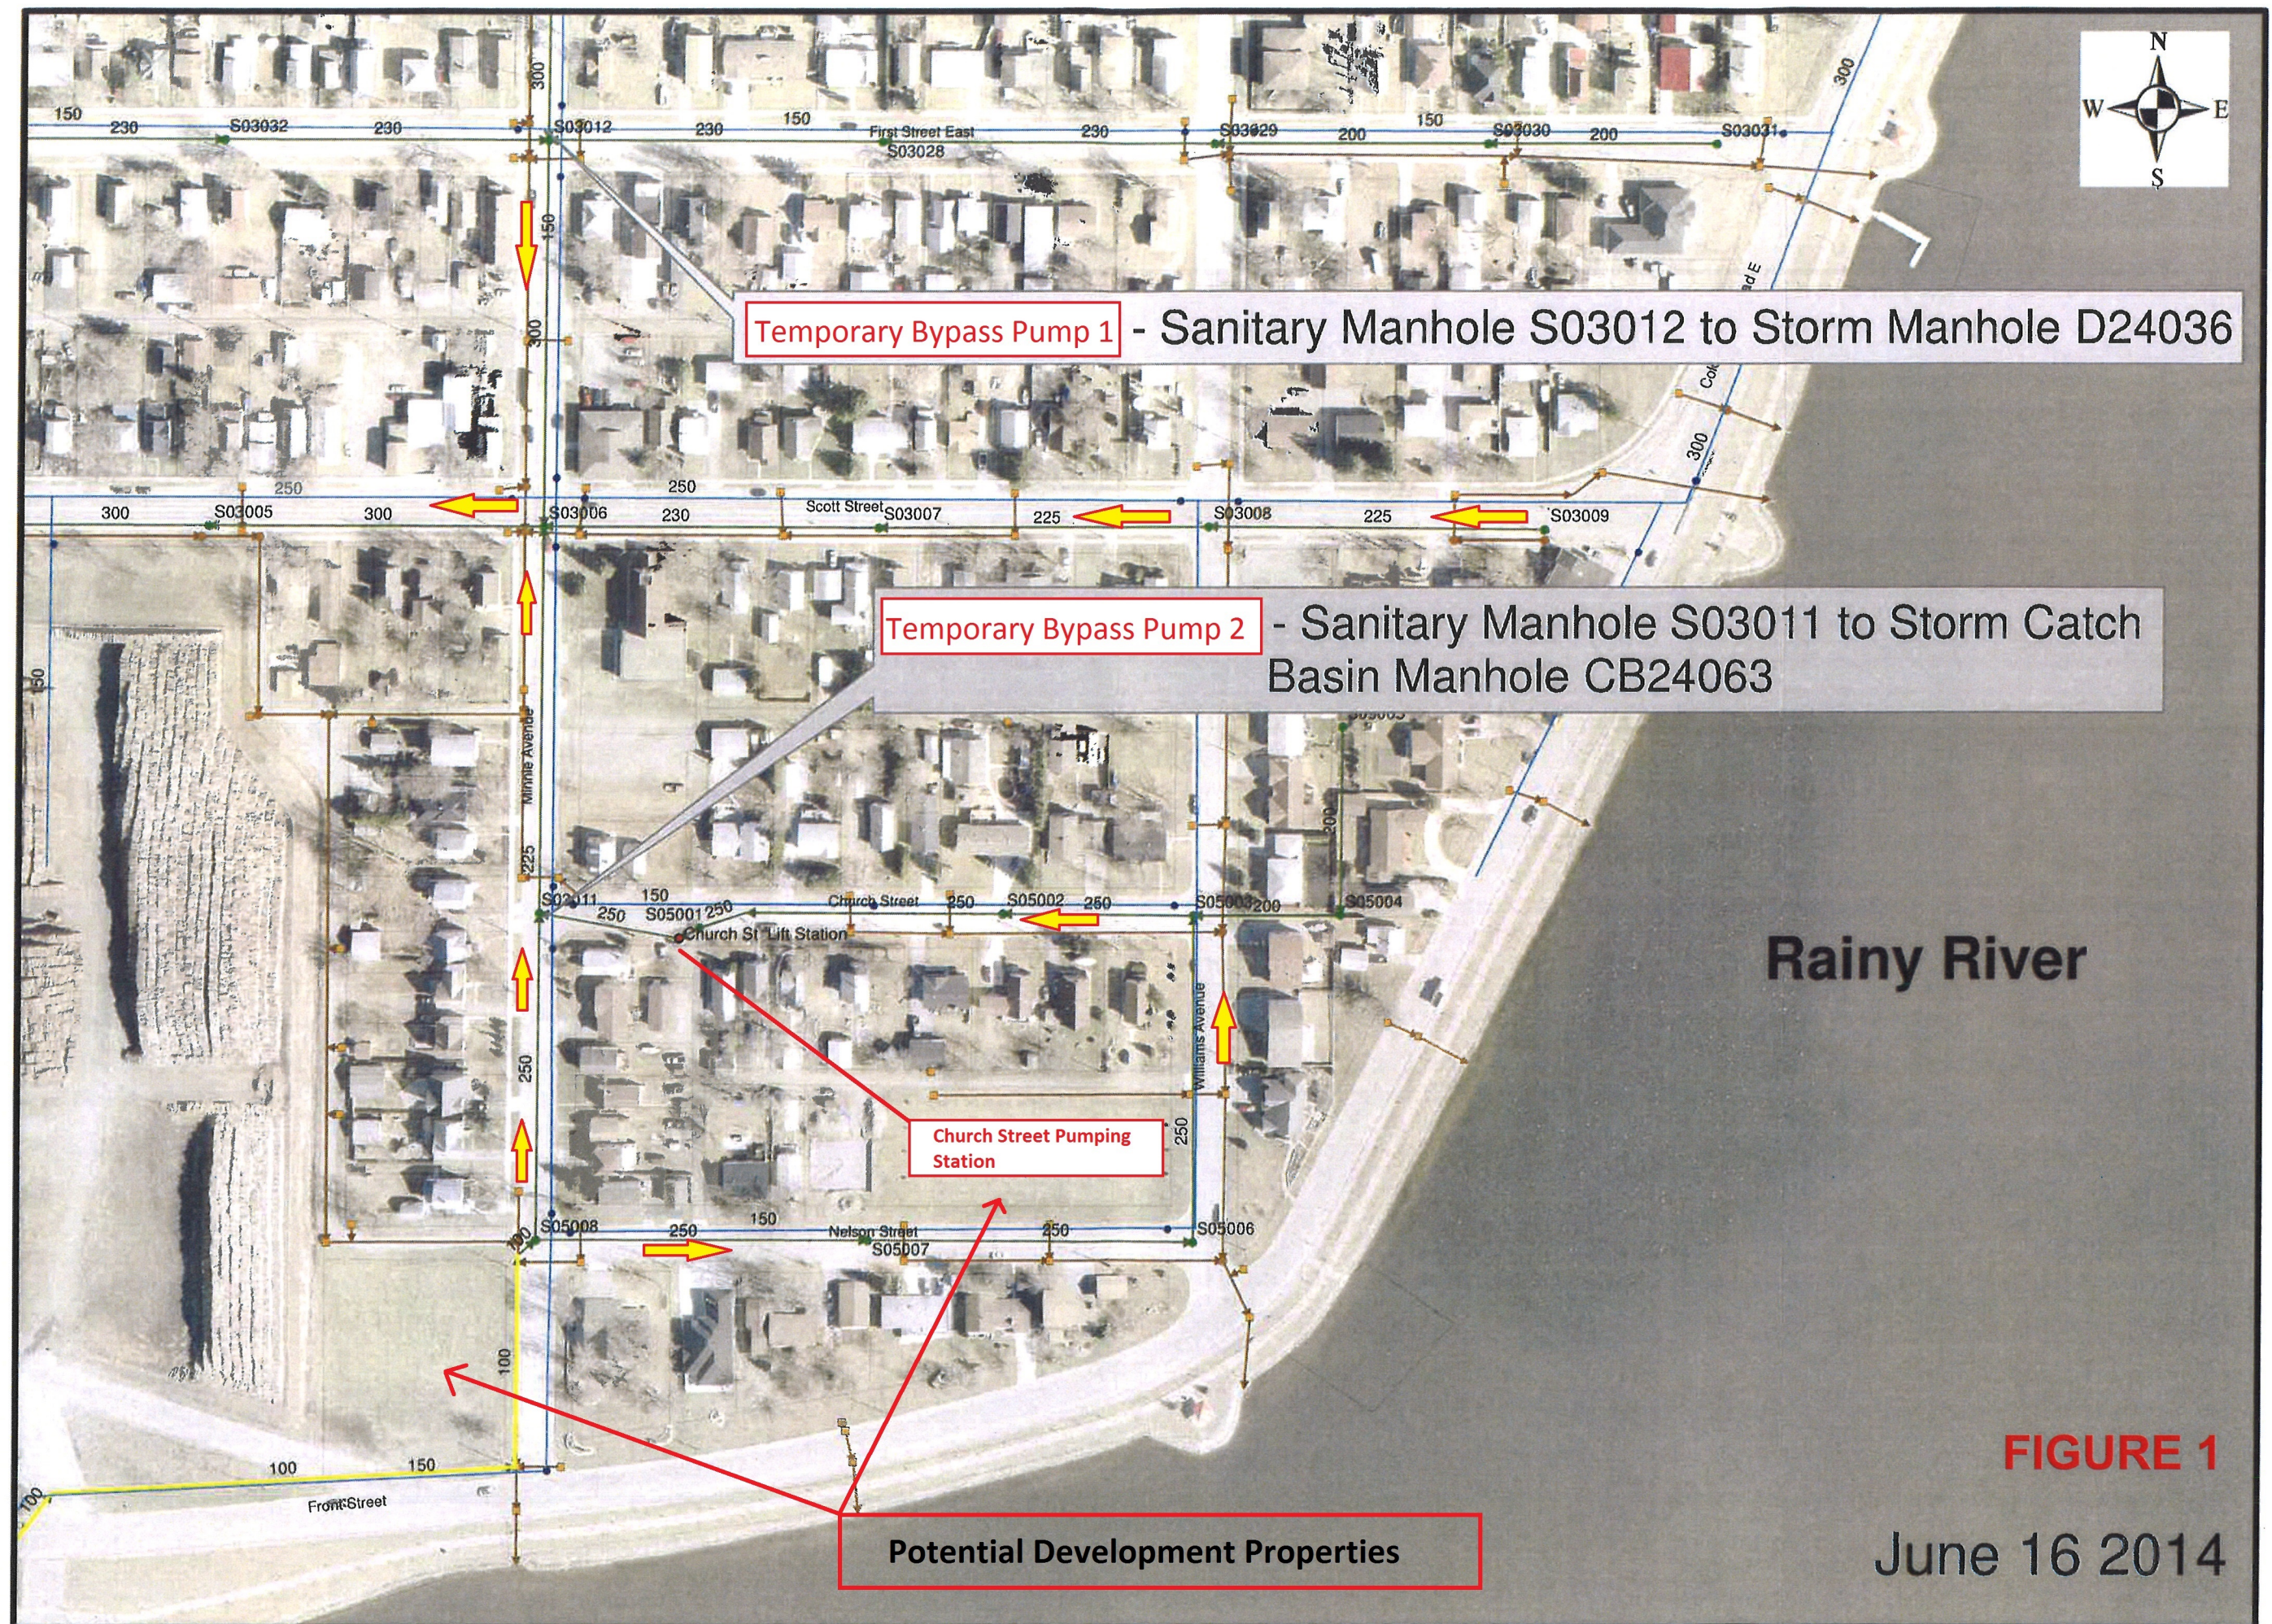
**FIGURE 1**

June 16 2014

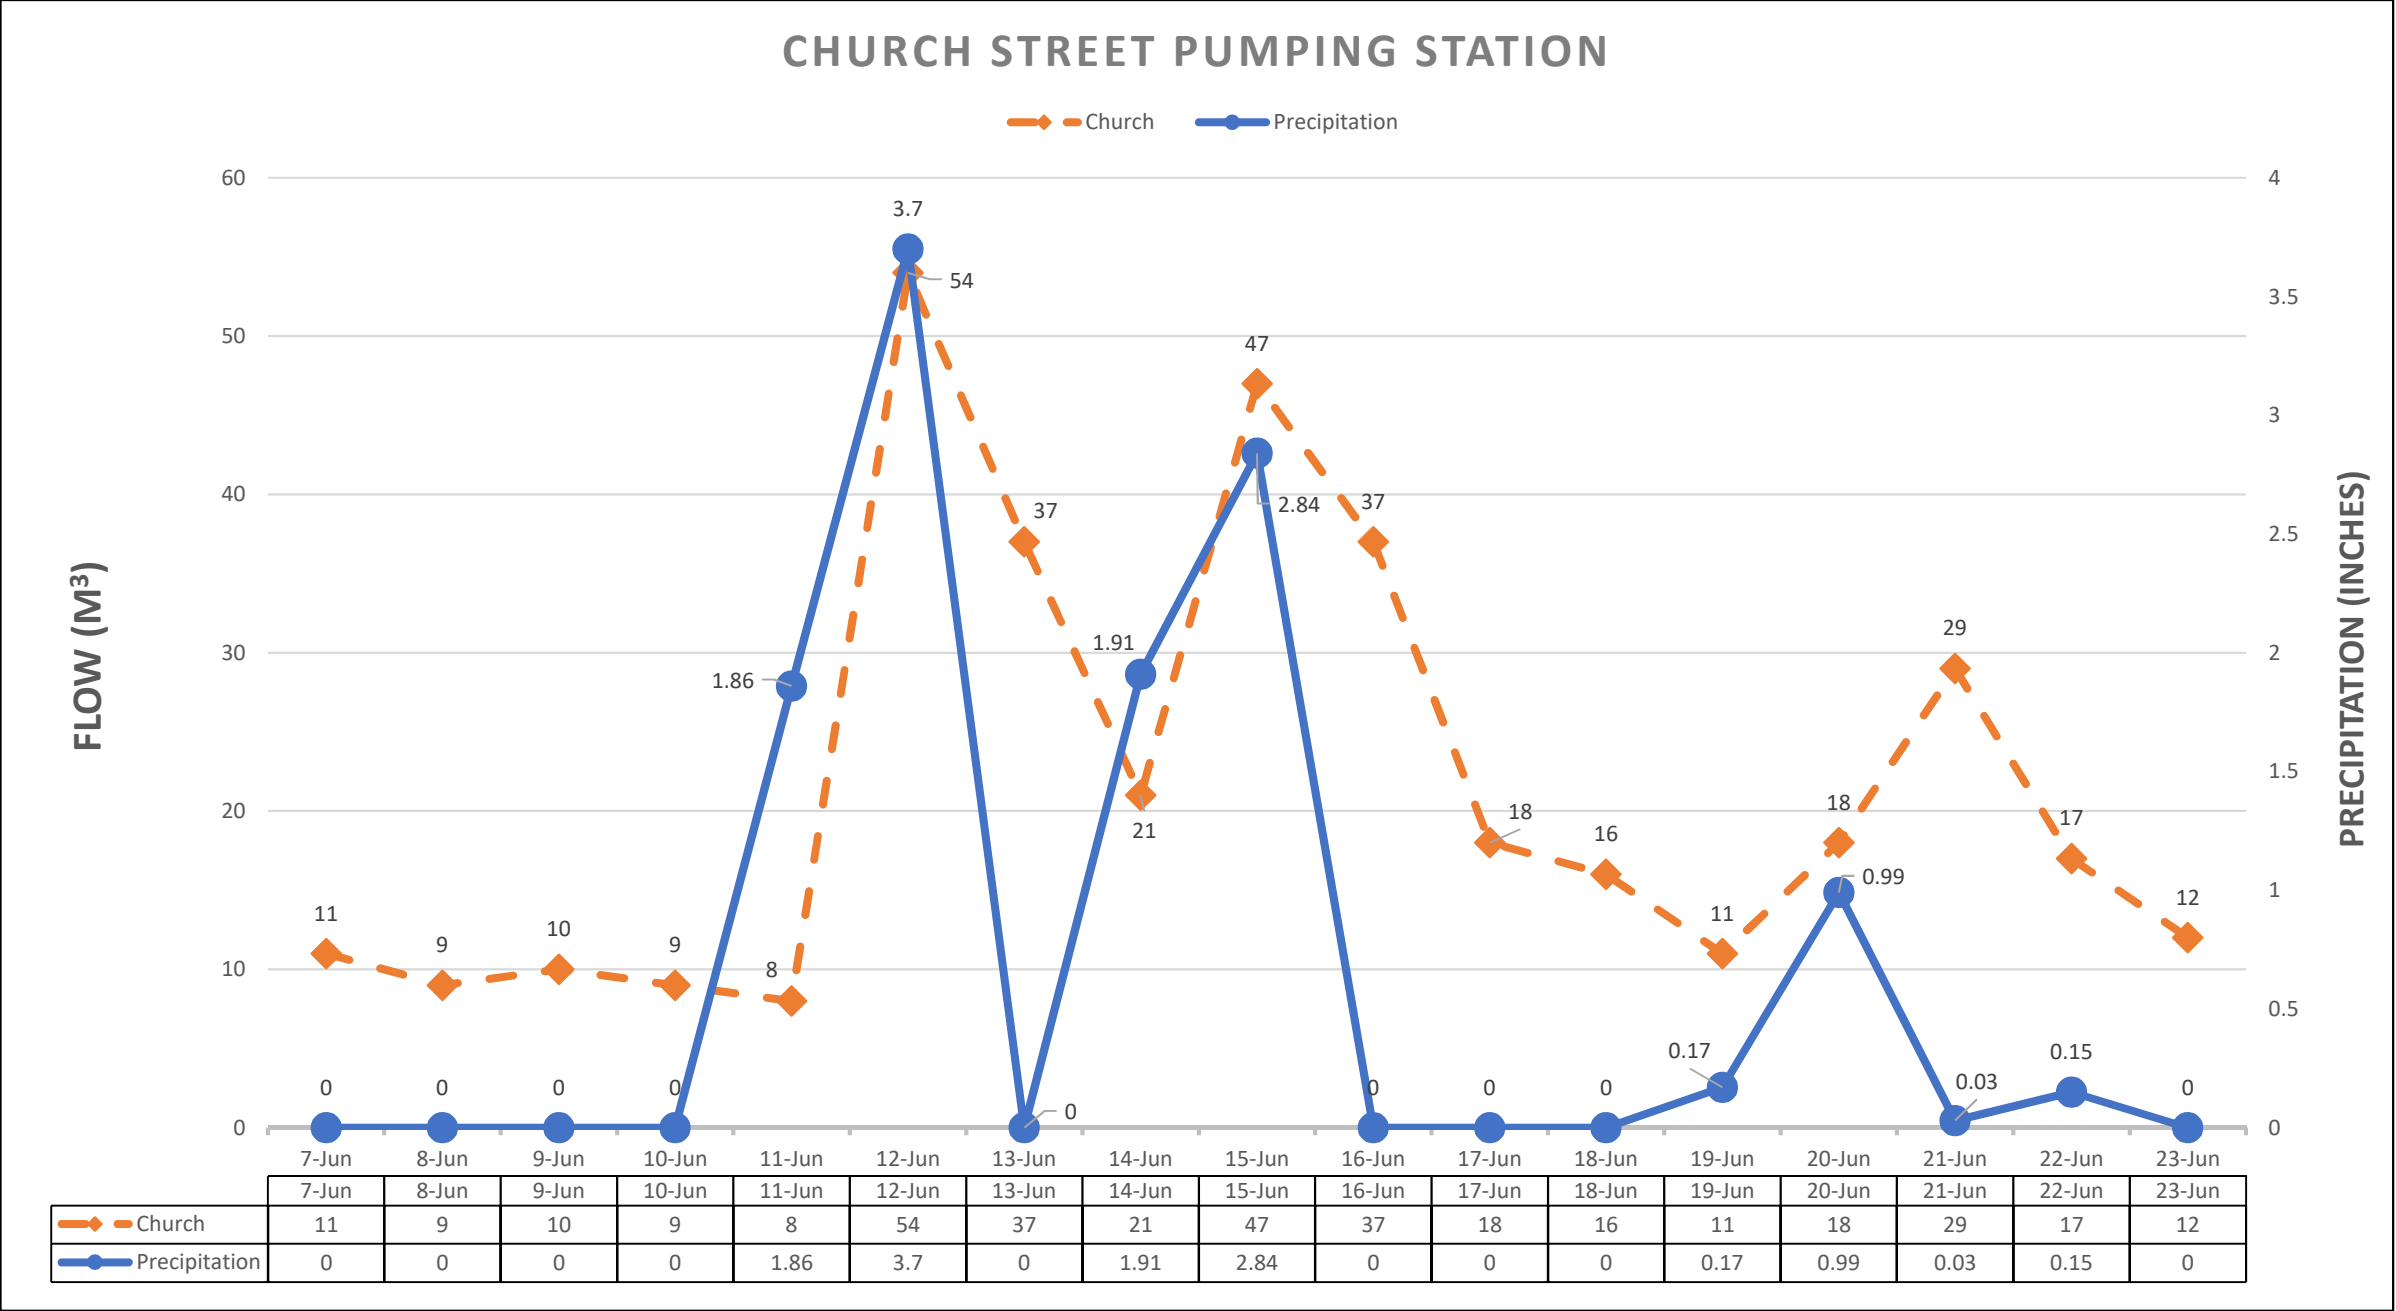
Town of Fort Frances  
East End Sanitary Sewer Study  
Rainfall Record  
(from International Falls Met Station)  
No Rainfall from 1:00pm June 12 to 12:00am June 13

A reaction of this nature is normally considered to be the result of inflow from direct connections to the sewer (though manholes, sump pumps and downspouts) and through weeping tile systems that have a good connection to the surface. The pump flow data is also affected by the by-pass pumping and probable short-circuiting in the Church Street pumping station.

However, when one compares the pump station flows for the period before the storm (June 7-11) with the flow after the storm there is a noticeable and sustained increase in flow which is considered to be due to ongoing infiltration. Both stations also show a flow spike following a rainfall event on June 20 which indicates a fairly direct connection between the ground surface and the sewer system.

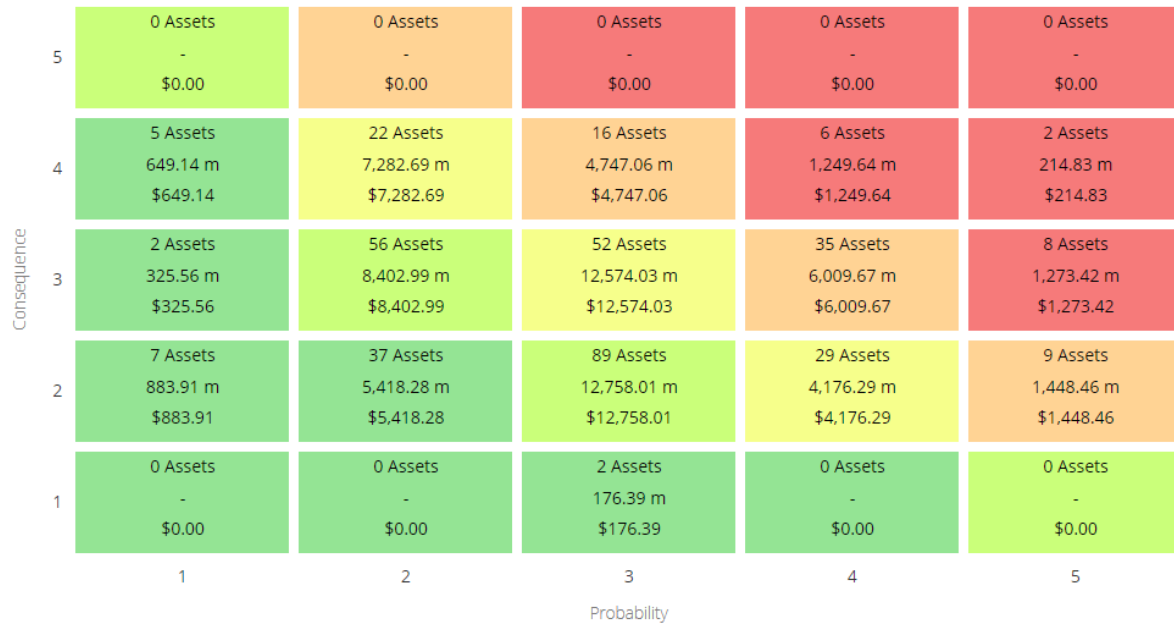
Figure 1-Risk Report for Paved Road

The system generates a risk report based on asset age, condition, MTO class and cost of maintenance. Figure 1 shows the risk distribution of the Paved Roads in the town. Most of the Paved Roads fall in the range of medium risk of failure, none of the Paved Roads in town are in extreme condition. The asset with higher road class has higher potential to failure, which is the major road segment in the road network.

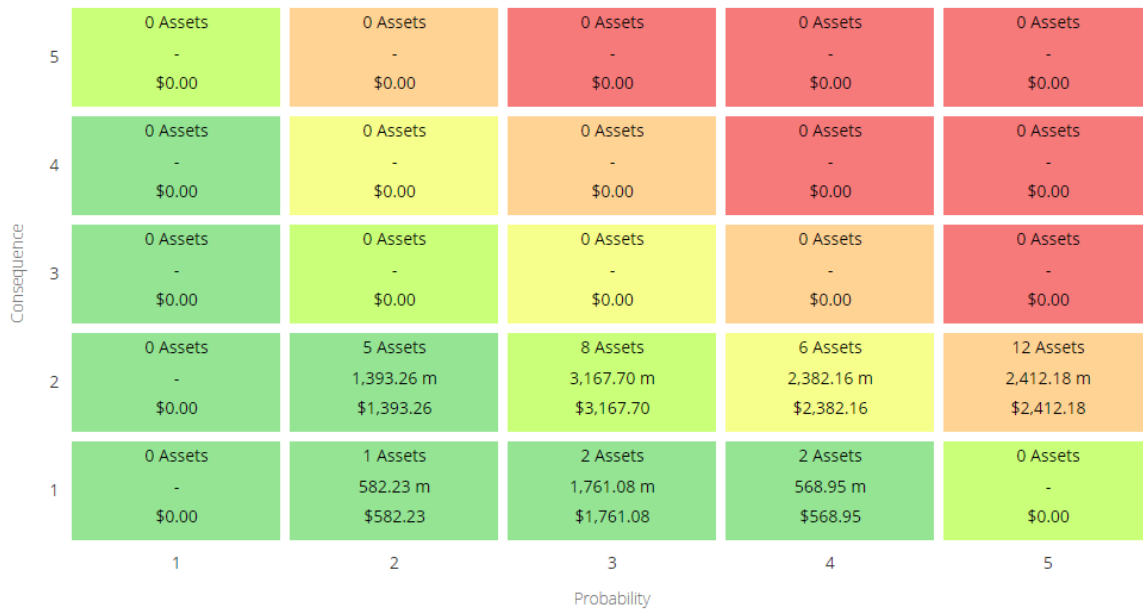
Figure 2-Risk Report for Surface Treatment Road

Figure 2 shows the risk distribution of the Surface Treatment Roads in the town. Most of the Surface Treatment Roads in medium to low risk of failure, the assets fall in the range of higher risk of failure may require road upgrading works to provide a better road service to road users.

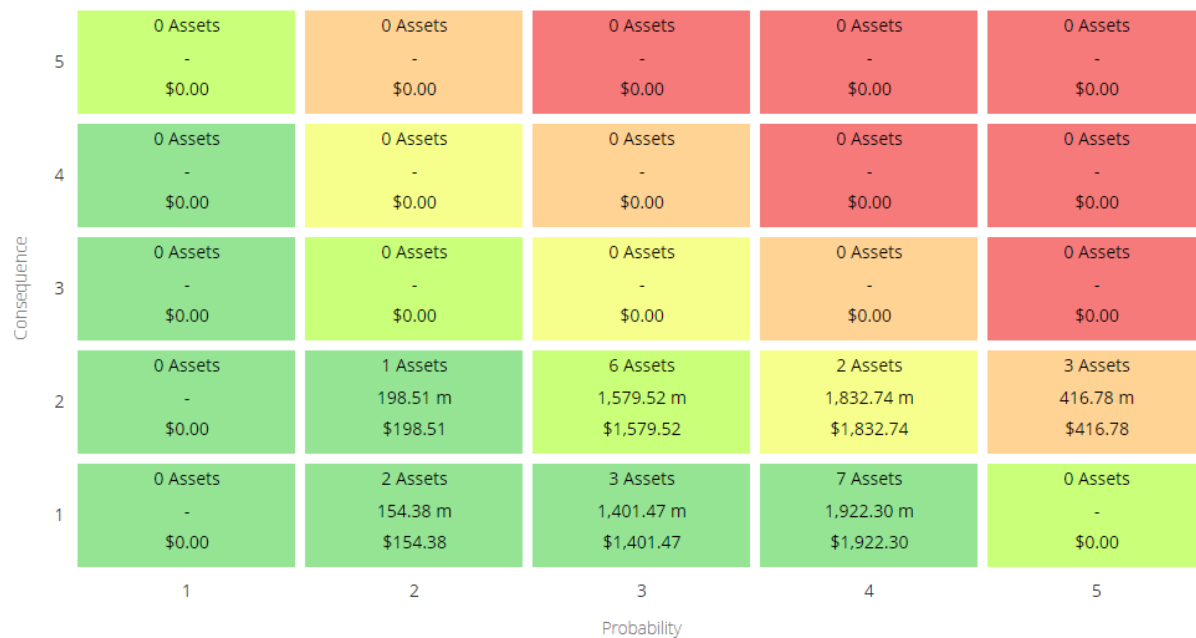
Figure 3-Risk Report for Unpaved Road

Figure 3 shows the risk distribution of Unpaved Roads in the town. All Unpaved Roads fall in the range of medium to low risk of failure. 13% of the assets are likely to failure, further maintenance works are required in these assets to improve their service.
